## PROPERTY INSPECTION REPORT

**123 Your Street, Your Town, Texas 75001**

**Date of Inspection: 12/10/2019 Time: 10:30am - Report#: 19121342**

**Inspector: Glen P. Ford**

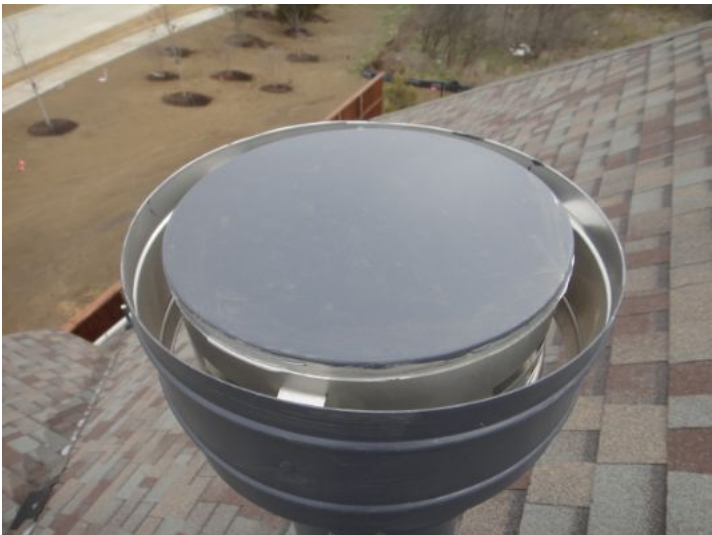
*Note: No evidence of any wind or hail damage noted at time of inspection - No dents to metal roof vents ( See photo )*

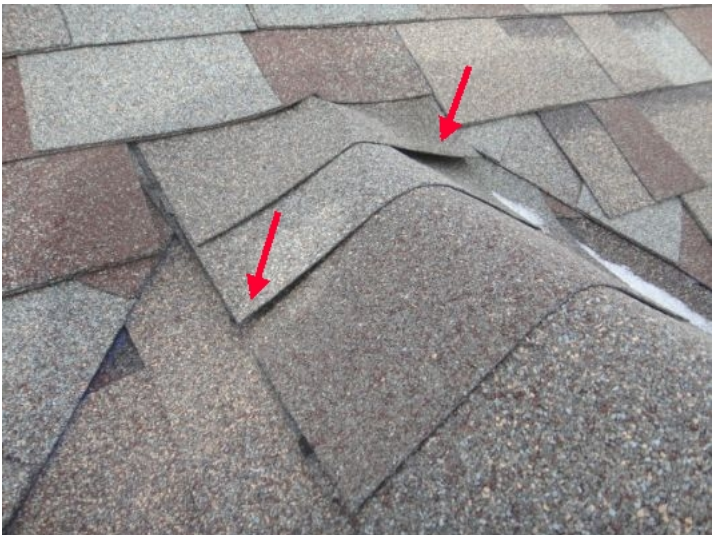
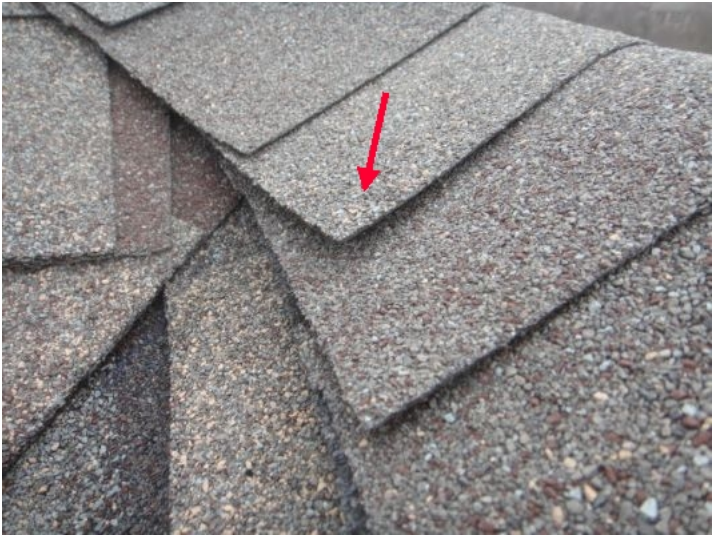
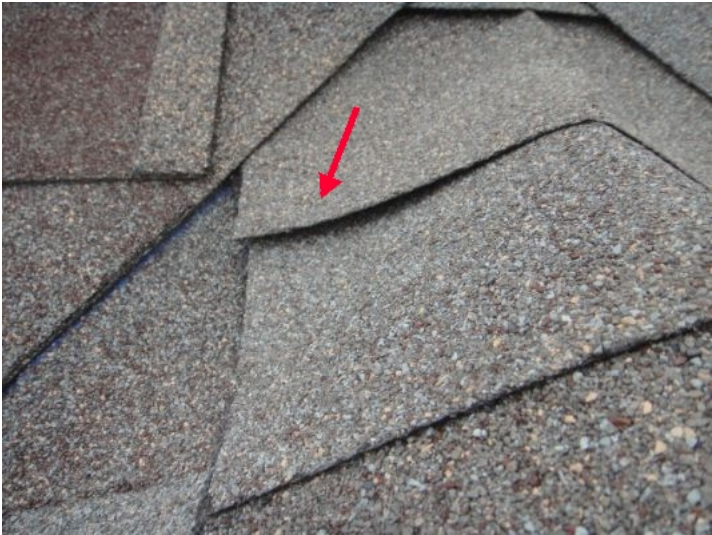
- **Deficiency -**
  - Several areas of uplifting ridge shingles are prone to wind damage (See photos)
  - 1 damaged shingle at NE ridge line - condition minor (See photo)

*Several areas of uplifting ridge shingles are prone to wind damage (See photos)*

- Unsealed roof fasteners near east chimney vent flashing - minor repair (See photo)
  - Note: Recommend further evaluation by roofing contractor for repair options

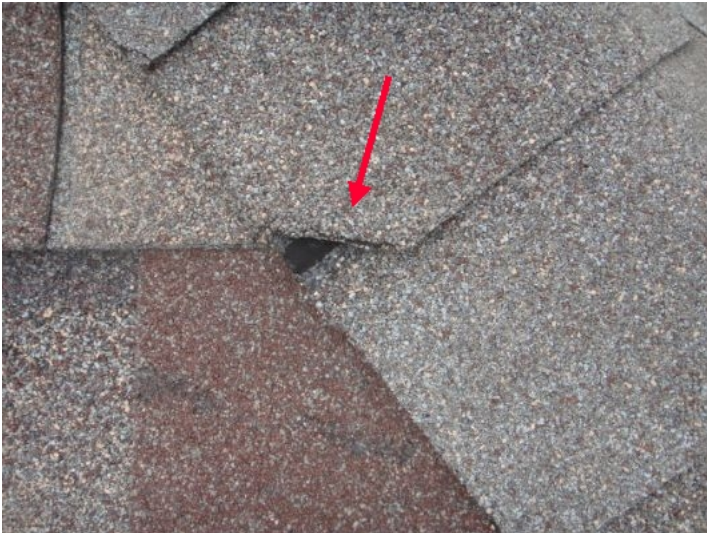
1 damaged shingle at NE ridge line - condition minor (See photo)

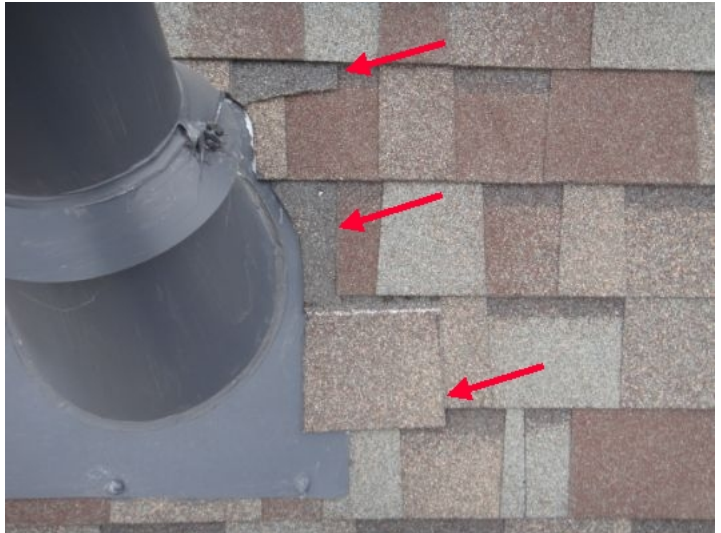
Loose shingles with missing sections at east chimney vent flashing area (See photo)

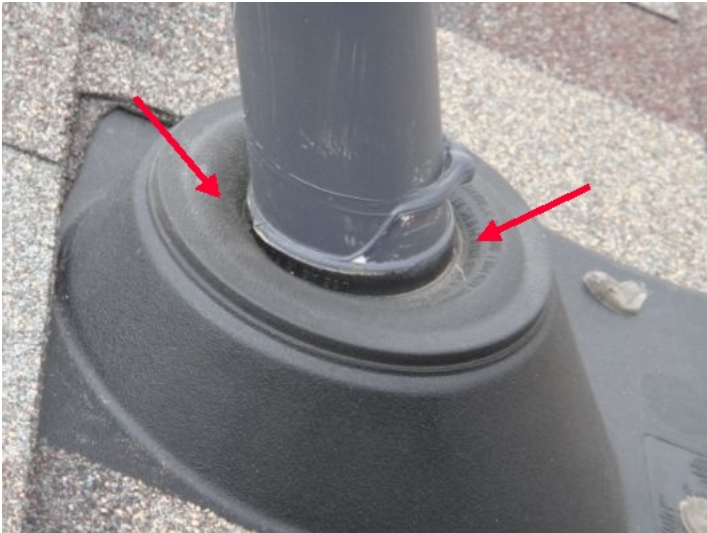
1 north plumbing vent roof jack has rubber seal inverted - will hold water - not typical - minor repair (See next photo)

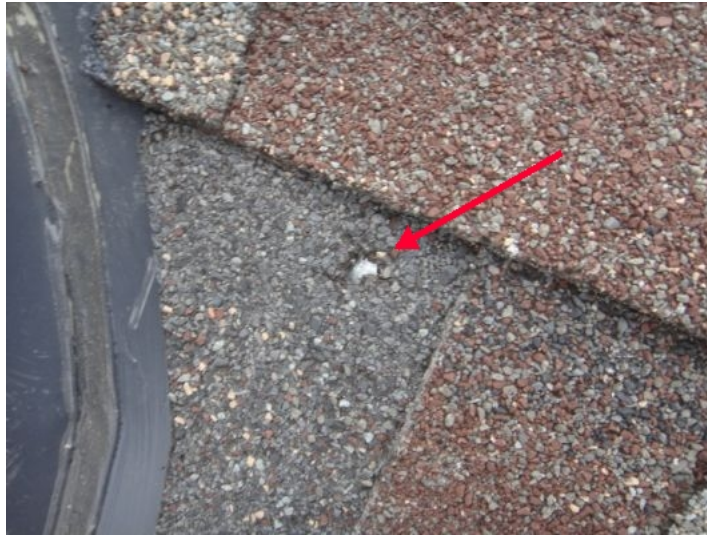
*Unsealed roof fasteners near east chimney vent flashing - minor repair (See photo)*

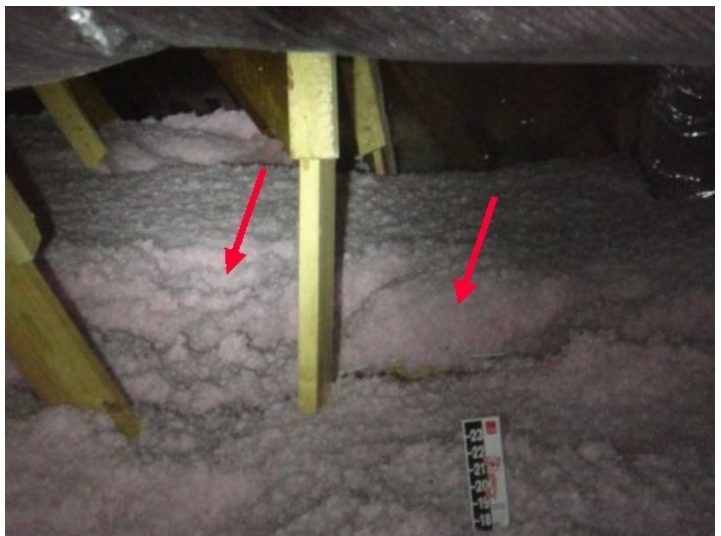
*Blown ceiling insulation is loose / disturbed at areas above den caused by worker foot traffic - no longer at posted depth in this area - discuss with client (See photo)*

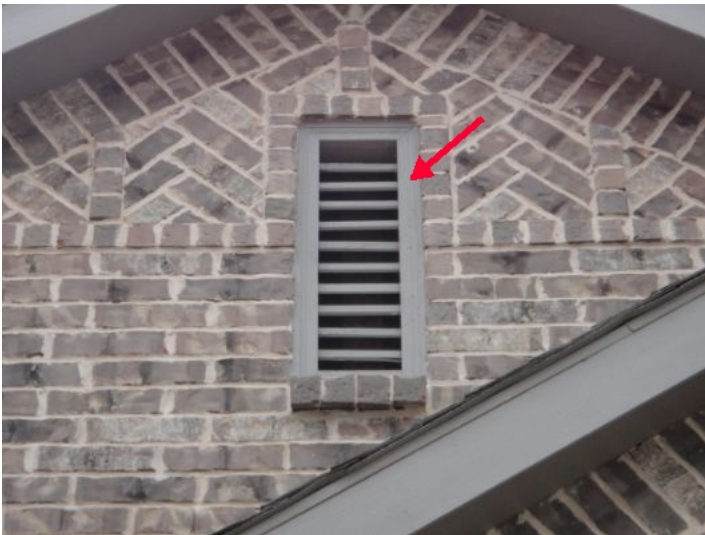
*Note: Decorative wood gable vents will require regular maintenance to prevent water damage - discuss (See photo)*

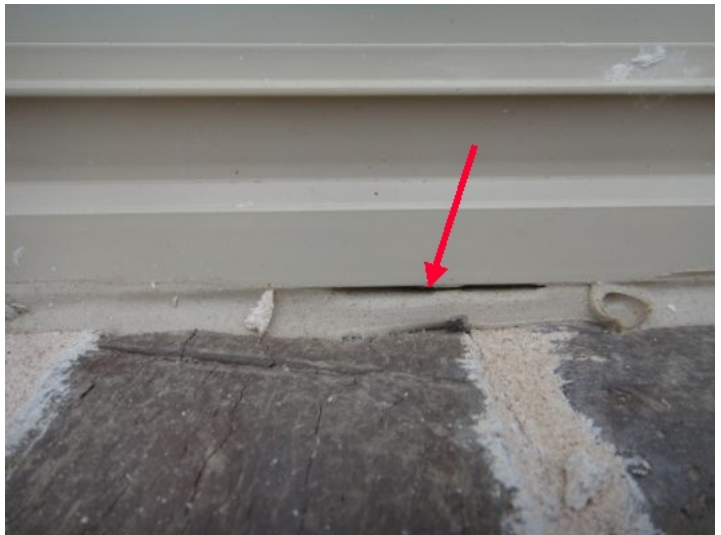
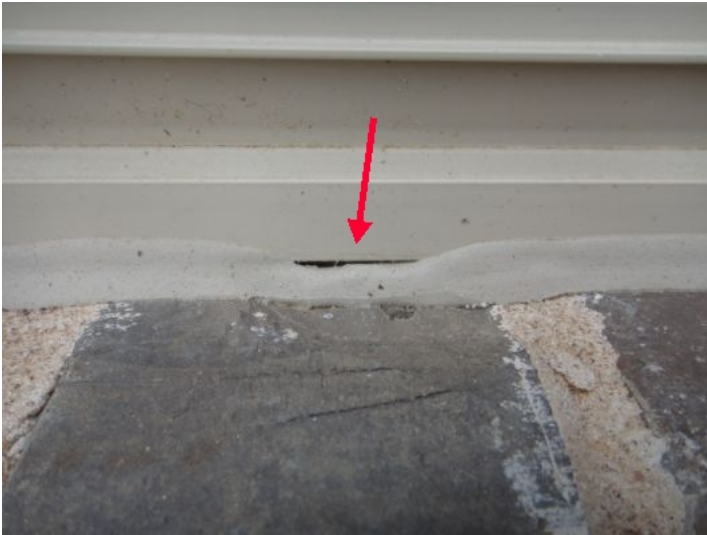
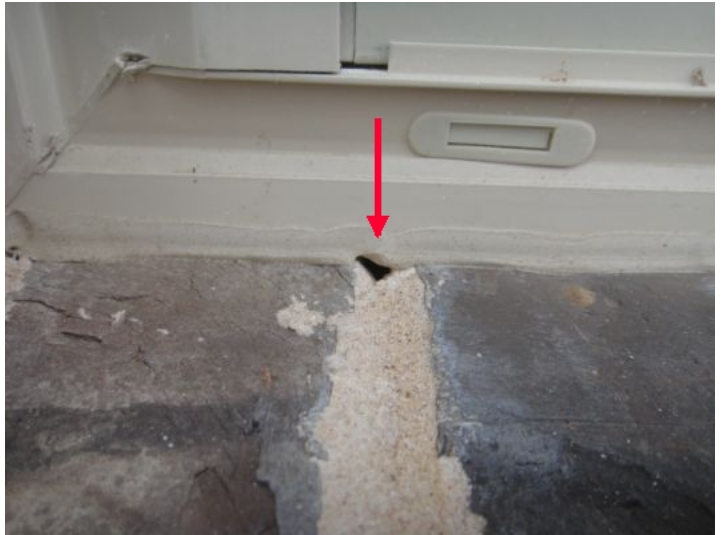
*Window frame to brick caulking failed / incomplete at random - minor repair (See photos)*

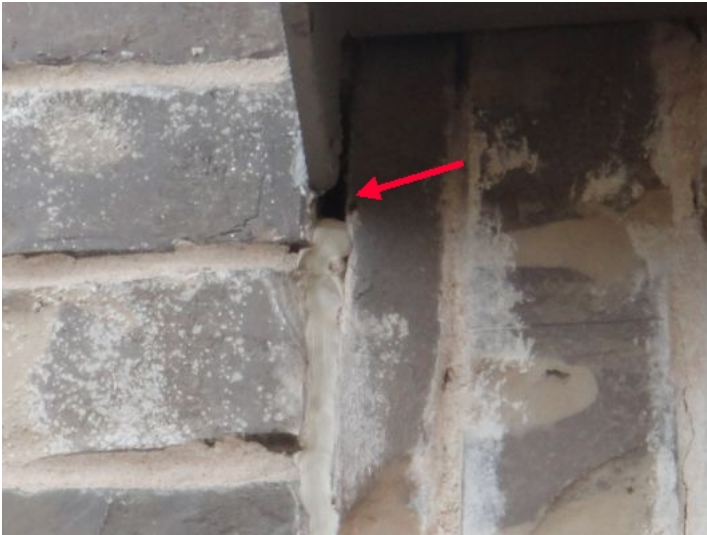
*North brick expansion joint has incomplete sealant at top resulting in small opening - minor repair (See photo)*

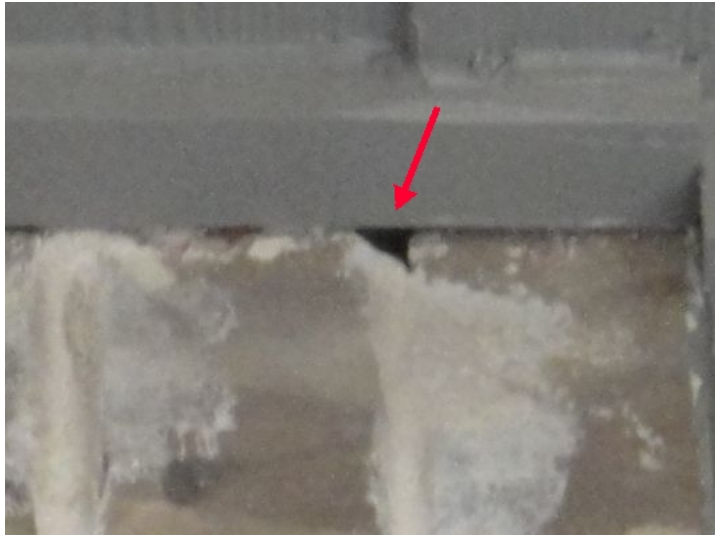
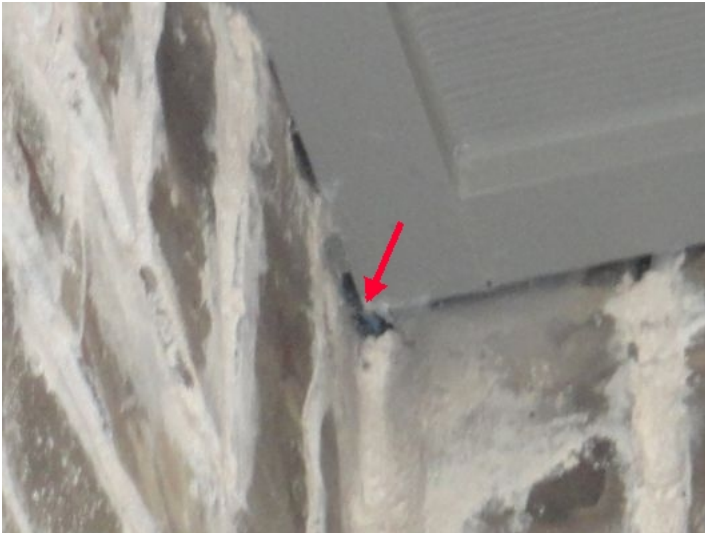
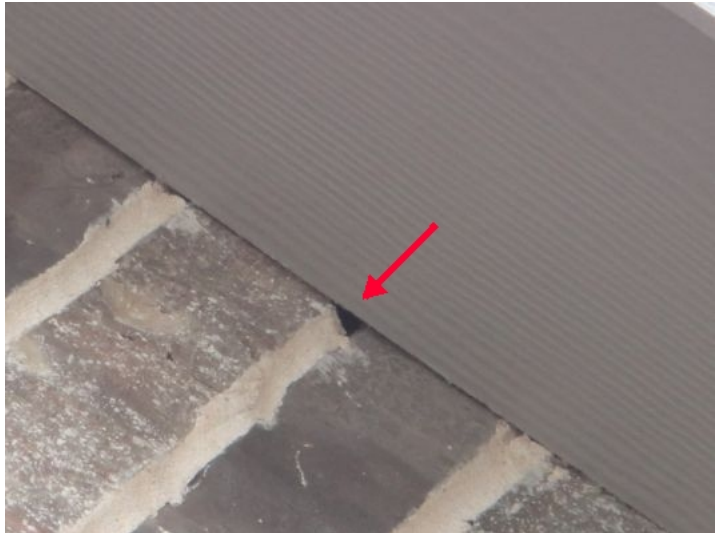
*Small areas of missing / incomplete brick mortar resulting in small openings where soldier bricks meet frieze board trim - minor repair (See photos)*

Small areas of missing / incomplete brick mortar resulting in small openings where soldier bricks meet frieze board trim - minor repair (See photos)

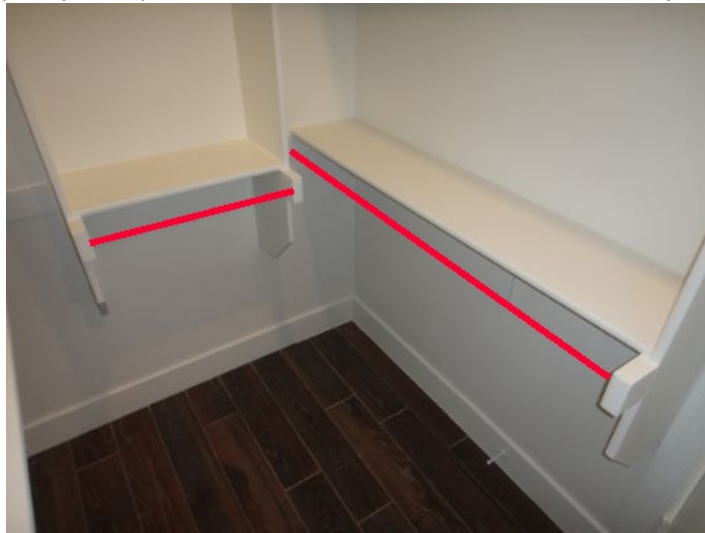
Missing clothes rods in master closet (See photo)

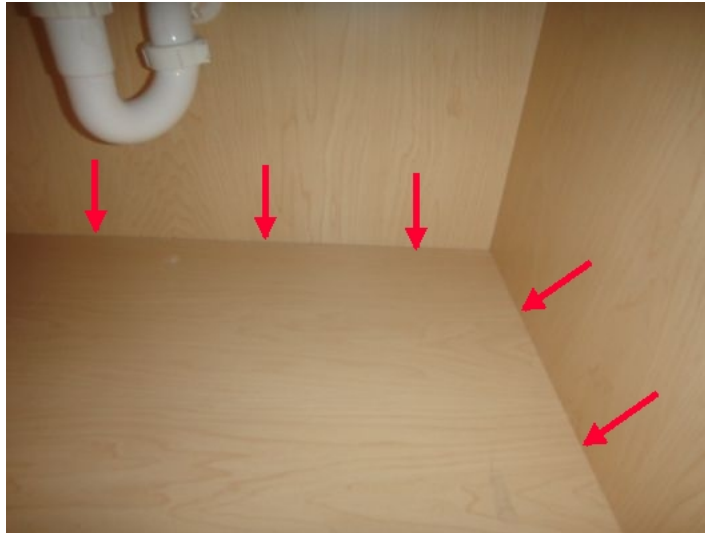
*Note: Discuss with client benefits of caulking / sealing all cabinet base joints - in the event of any leakage - water would drain onto floor in front of cabinet and be readily observable instead of leaking in wall / structure (See photo)*

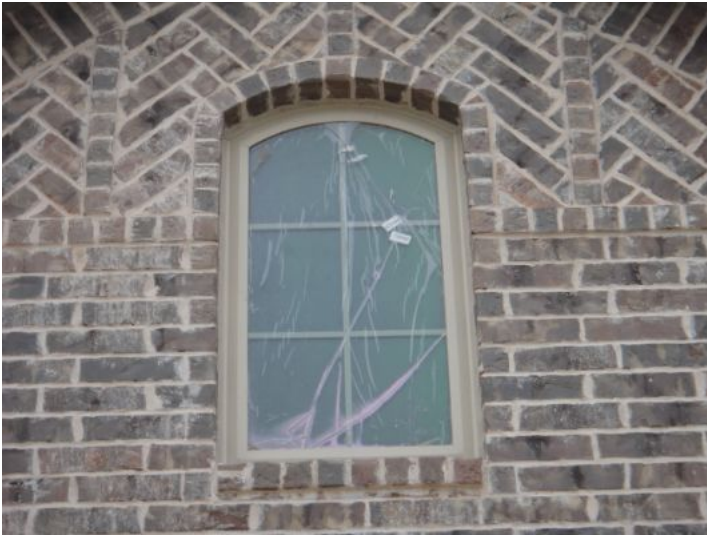
Attic window above driveway has plastic covering installed but appears cracked - consult builder (See photo)

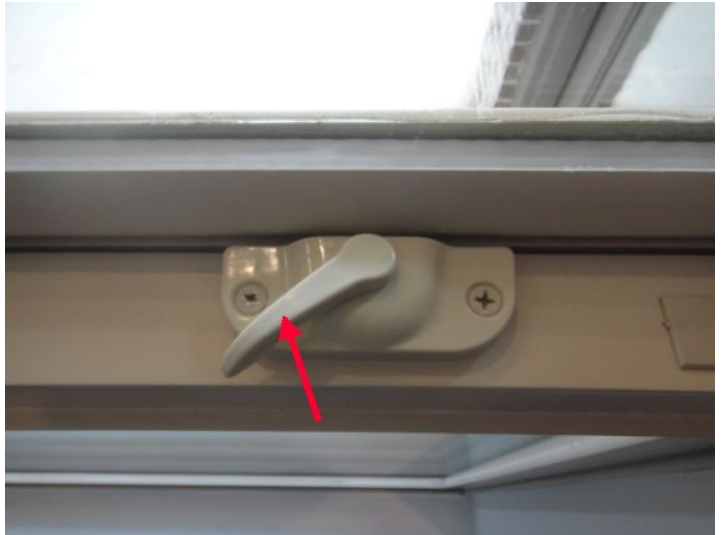
Some windows require excessive force to close latches when in full down position - not typical (See photo) - 2 of 3 windows in den, 2 of 4 in master bedroom, study LH window

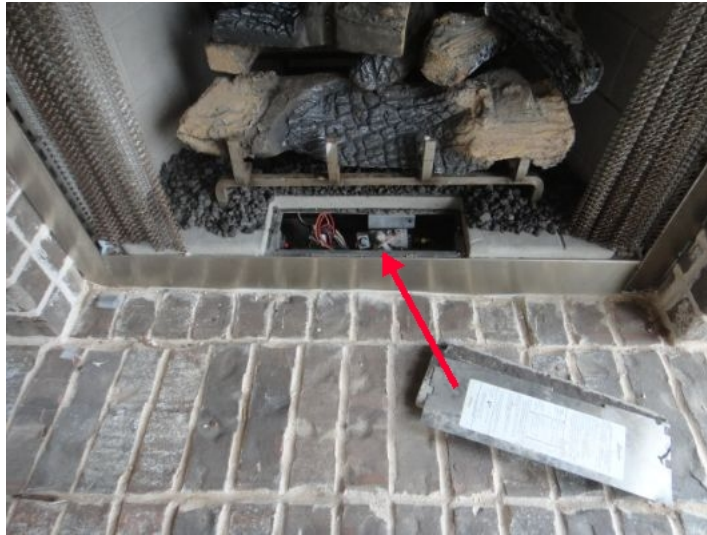
*Autostart gas log installation incomplete at rear patio fireplace - not operated or inspected - consult builder for specifics (See photo)*

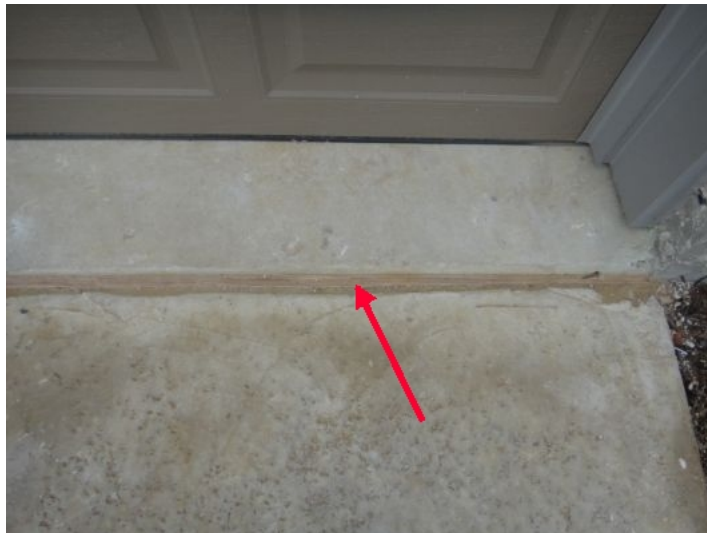
- All components were found to be performing and in satisfactory condition at the time of the inspection
- Note: Wood expansion joint used at driveway creating wood to ground condition - potential attractant for wood destroying insects - discuss (See photo)

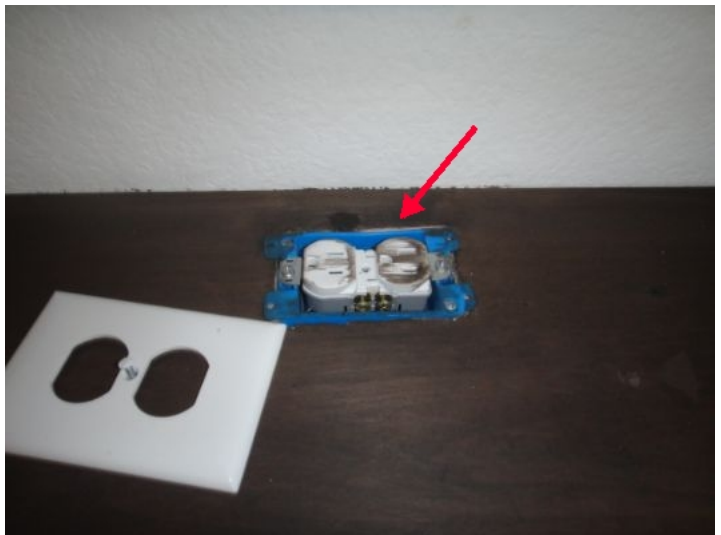
Loose outlet cover at fireplace mantel outlet - minor repair (See photo)

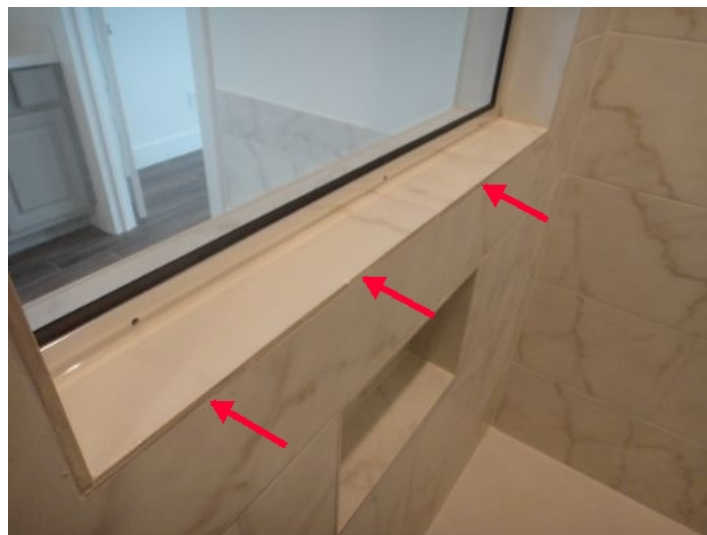
Note: Master shower tile has sharp cut edges that could be considered a potential hazard - discuss with client (See photo)

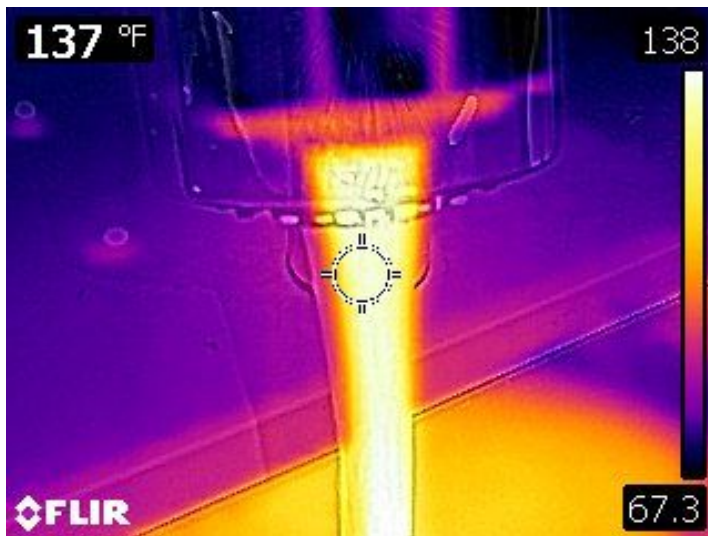
Measured hot water temperature at the kitchen sink faucet was 137 Degrees F. - potential scald hazard - temperature adjustment recommended (See photo & scald chart)

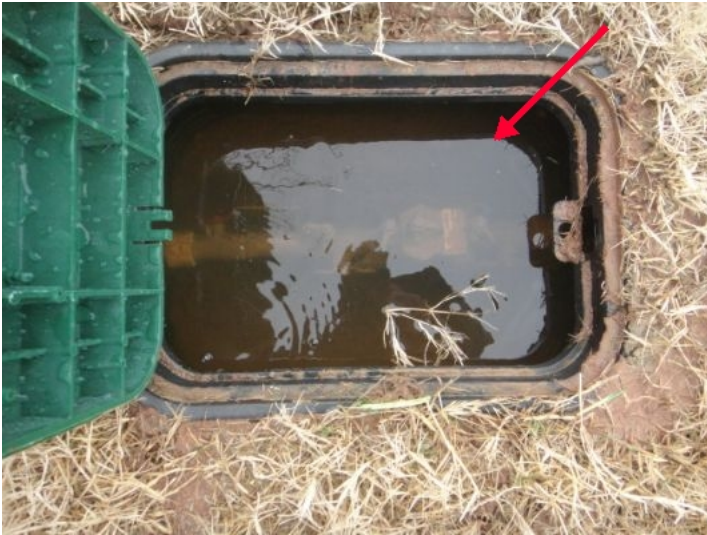
Note: Sprinkler system backflow preventer valve located in front yard valve box ( See photo ) - valve box full of standing water at time of inspection - discuss

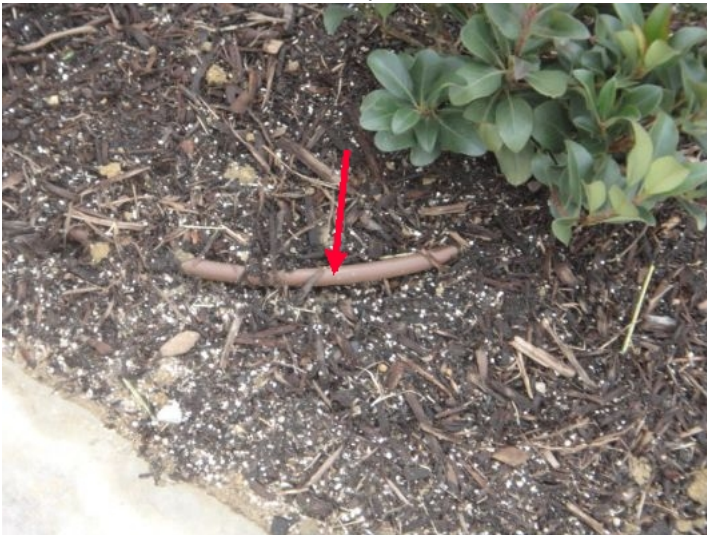
Exposed drip line in flower bed south of driveway - subject to damage - condition minor (See photo)

- Some spray heads partially spraying onto exterior surfaces of home - may require final adjustment - discuss seasonal adjustment with client
- Note: Recommend further evaluation by sprinkler contractor

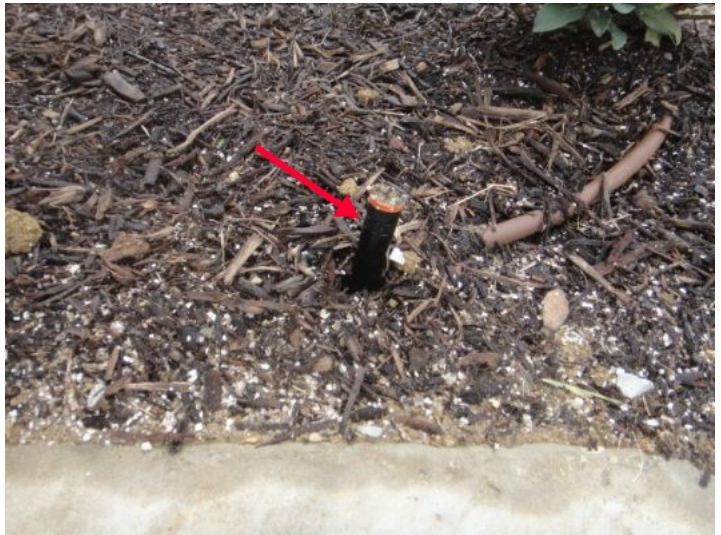
Zone 3 has 1 head that extends but does not spray at flower bed south of driveway (See photo)
