## PROPERTY INSPECTION REPORT

**123 North Texas Dr., Your town, Texas 75001**

**Date of Inspection: 11/11/2019 Time: 10:30am - Report#: 19115234**

**Inspector: Glen P. Ford**

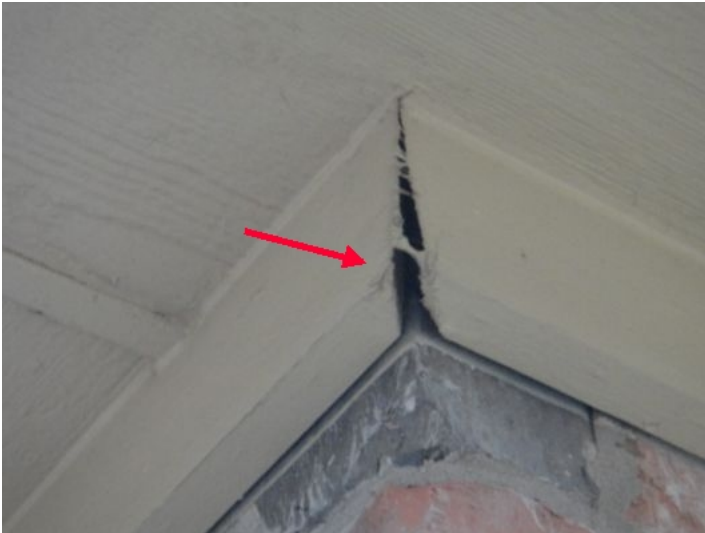
- Minor settlement typical of age at SW corner has resulted 3/8 inch separation of frieze board trim at SW corner (See photo), Minor separation of brick at south window opening (See photo) & minor brick mortar cracks at south expansion joint area (See photo)

3/8 inch separation of frieze board trim at SW corner

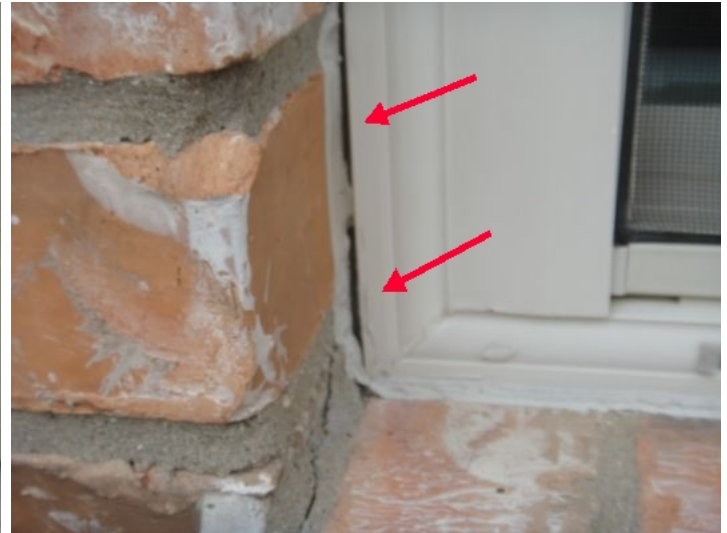
Minor separation of brick at south window opening

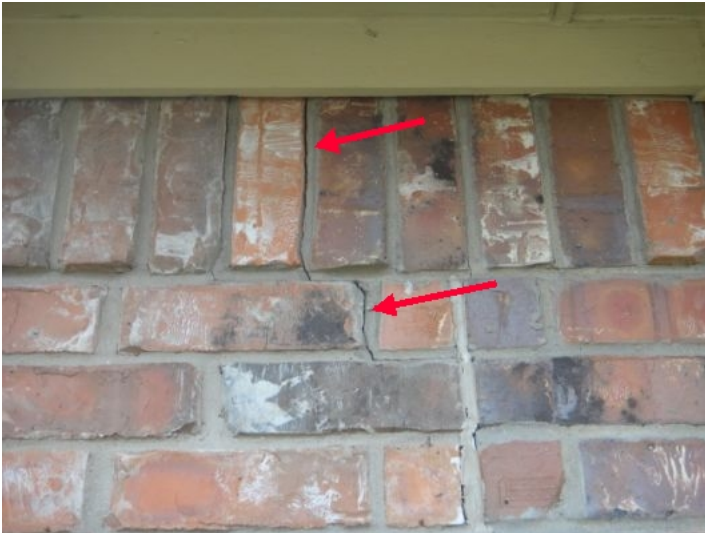
Brick mortar crack at south expansion joint area

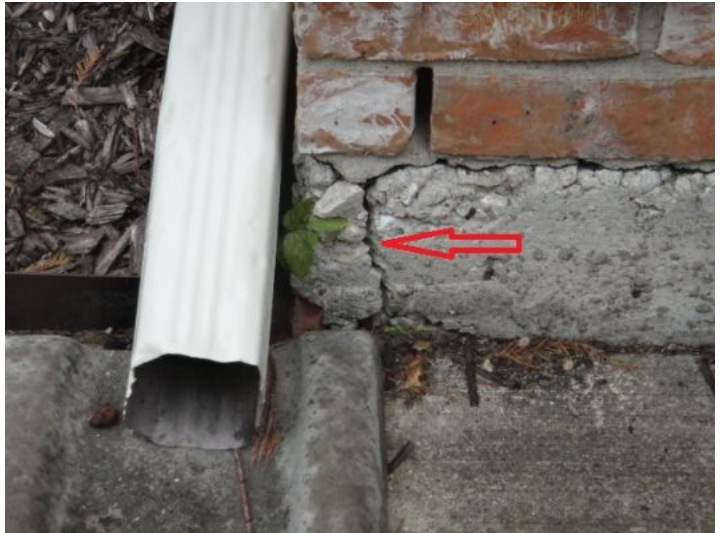
Note: Observed foundation corner breaks caused by seasonal flexing of foundation - not uncommon for age - not a structural concern ( See photo )

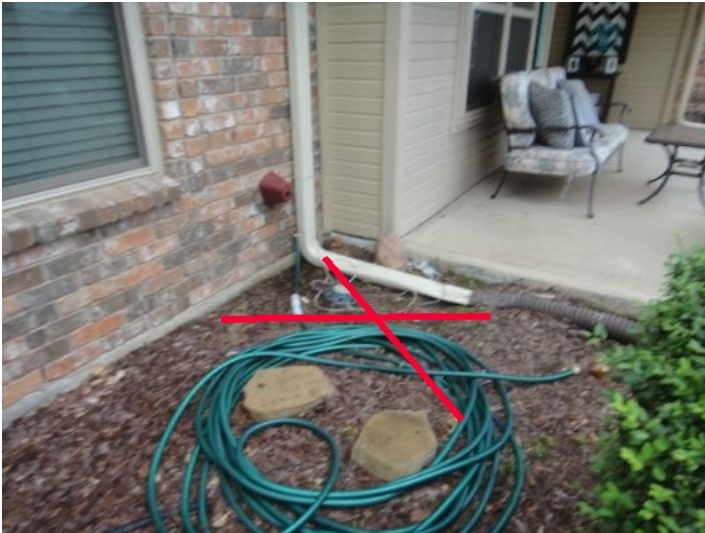
Low area with evidence of water ponding in front flower bed (See photo)

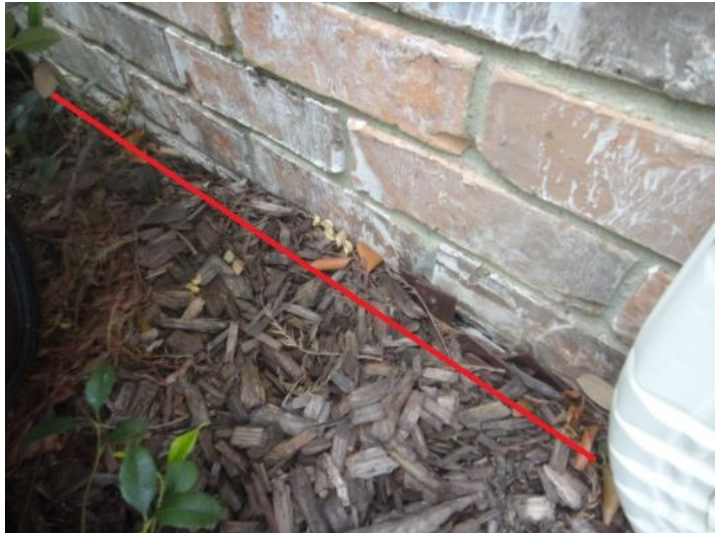
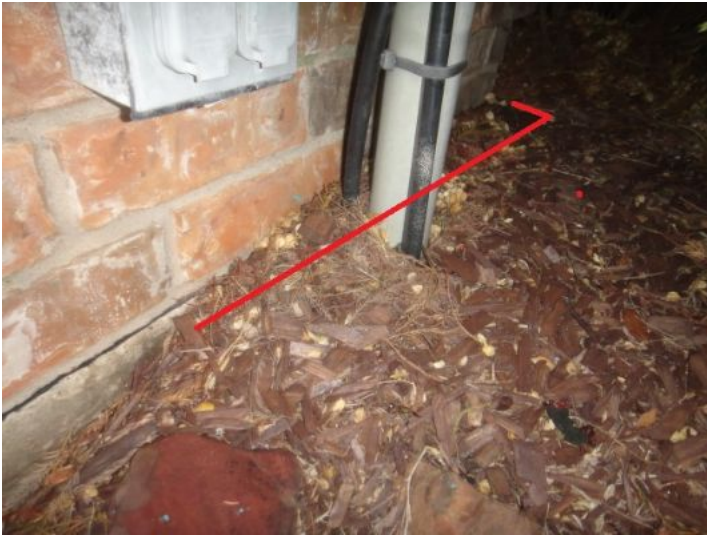
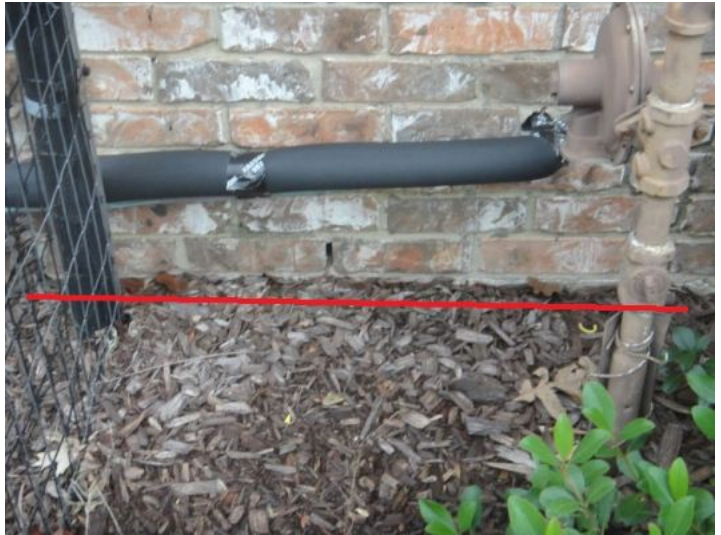
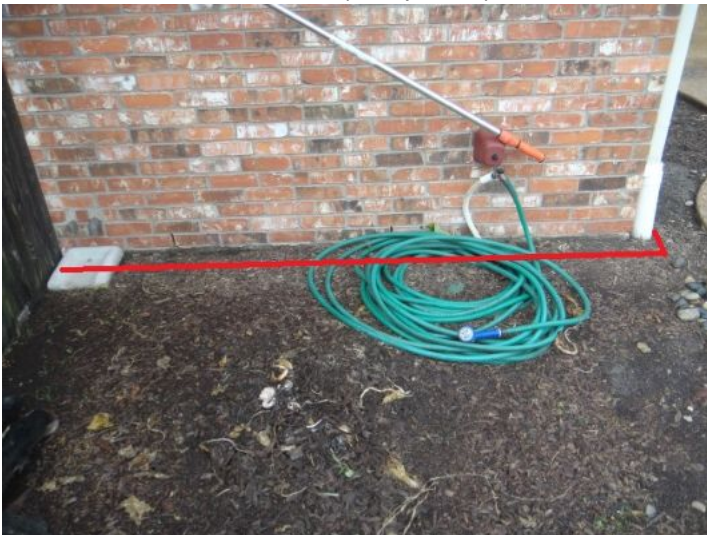
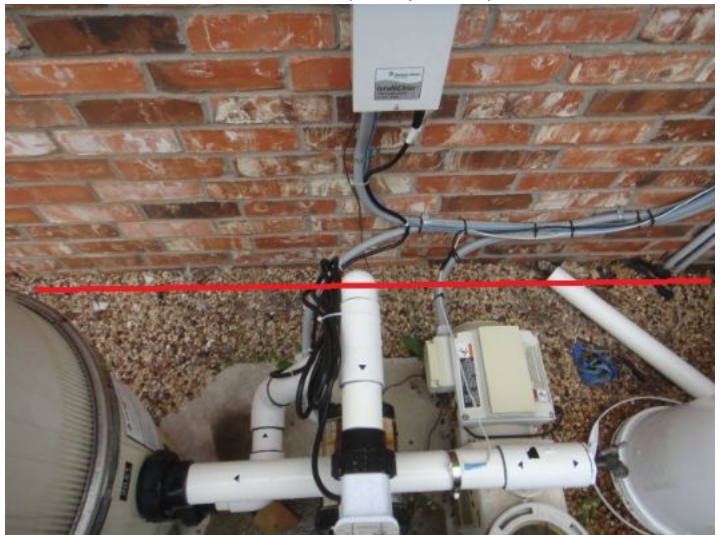
- Foundation perimeter grade too high ( above brick line ) at random flower bed areas and at pool equipment area - finished grade should be maintained 2 to 4 inches below brick line - this could force water penetration during heavy rain event (See photos)

Foundation perimeter grade too high ( above brick line ) at random flower bed areas and at pool equipment area - finished grade should be maintained 2 to 4 inches below brick line - this could force water penetration during heavy rain event (See photos)

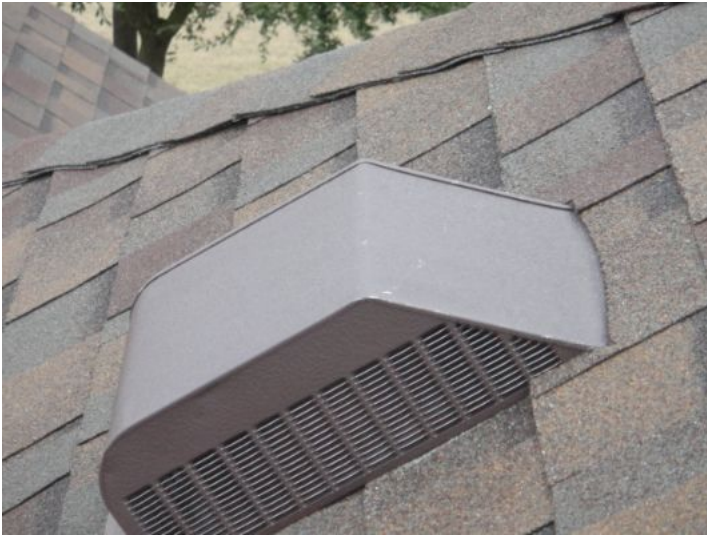
*Note: No evidence of any wind or hail damage noted at time of inspection - No dents to metal roof vents ( See photo )*

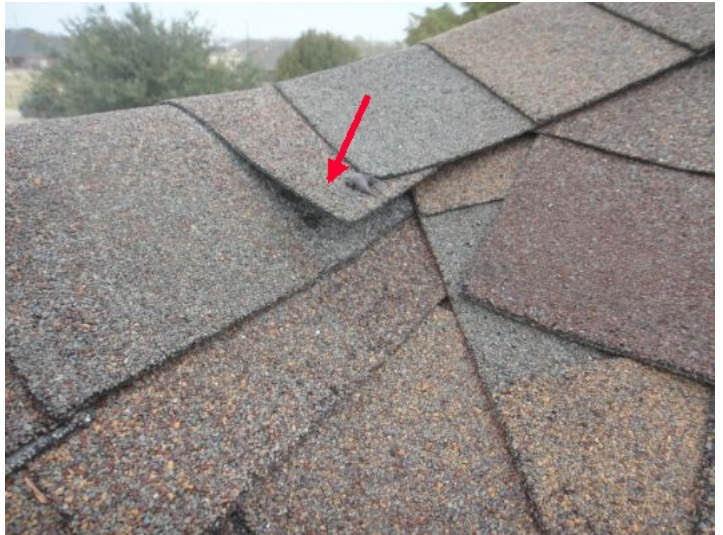
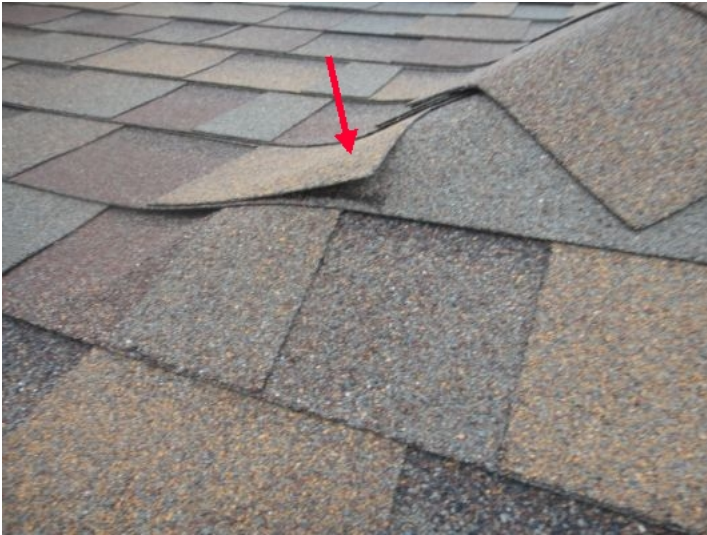
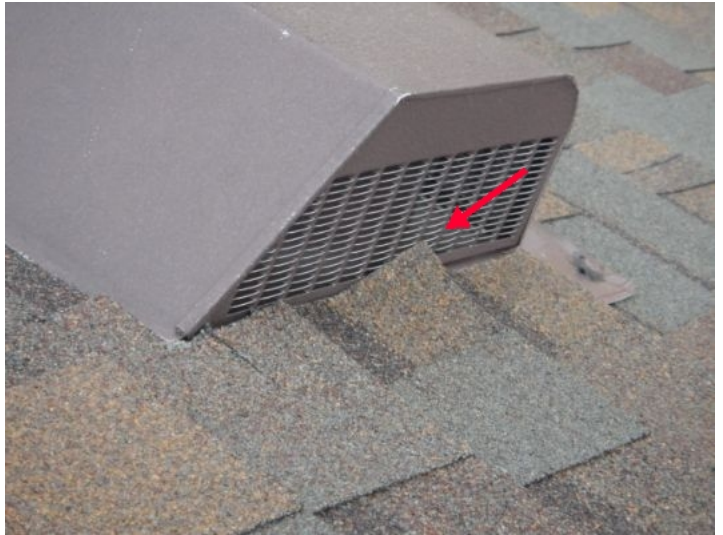
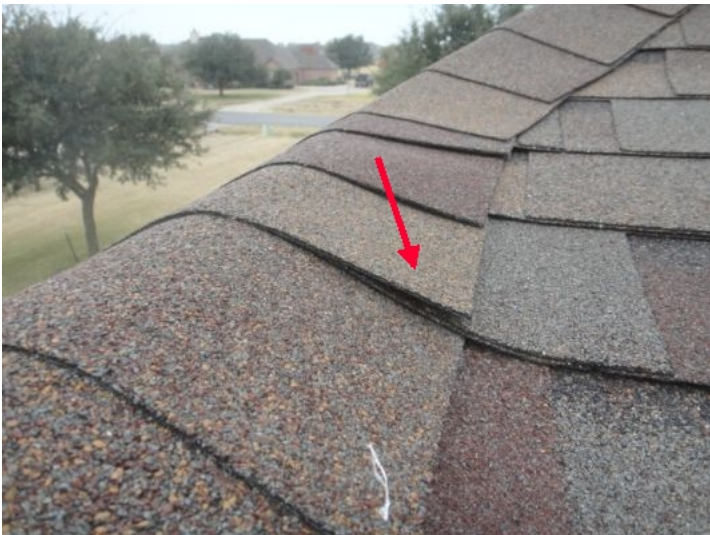
- Random uplifting shingles are prone to wind damage ( See Photos )

*Random uplifting shingles are prone to wind damage ( See Photos )*

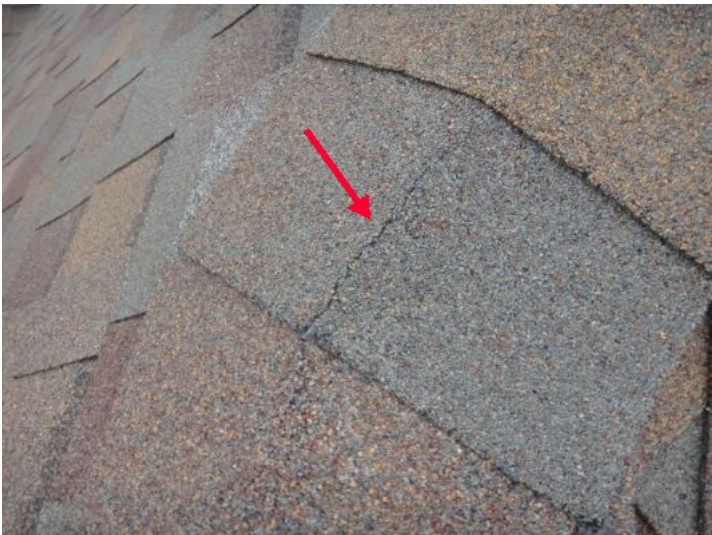
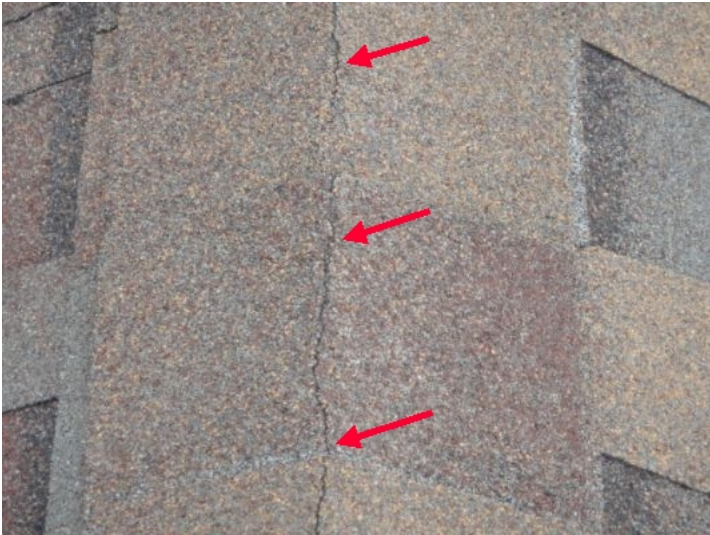
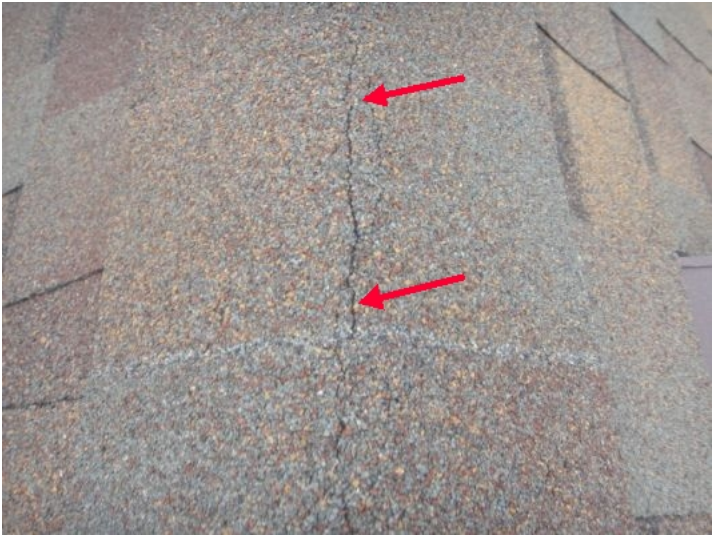
- Random areas of split / cracked ridge shingles - recommend to seal (See photos)

Random areas of split / cracked ridge shingles - recommend to seal (See photos)

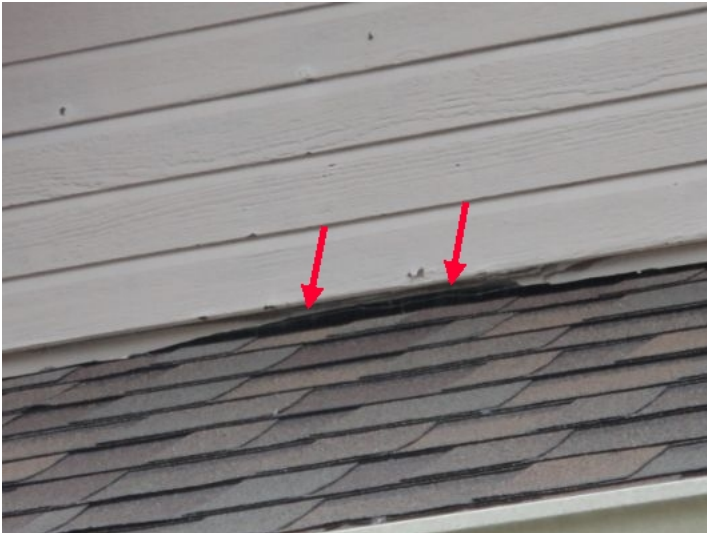
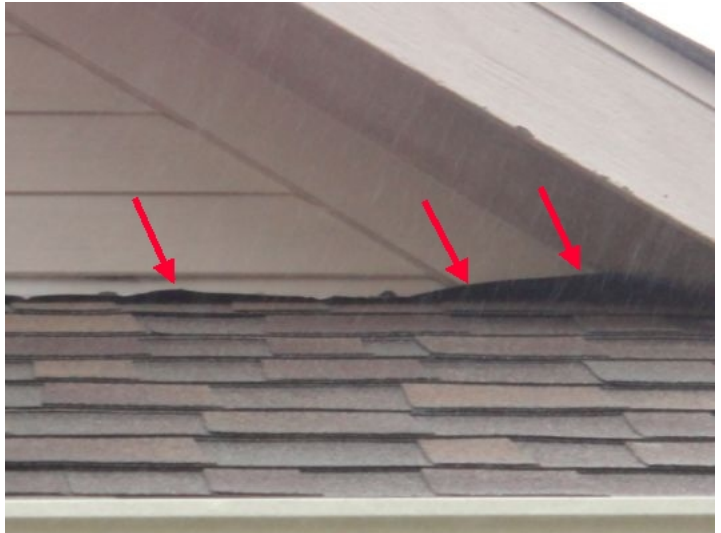
- West metal counter flashing uplifting above front patio - can result in leakage - needs proper securing (See photos)

West metal counter flashing uplifting above front patio - can result in leakage - needs proper securing (See photos)

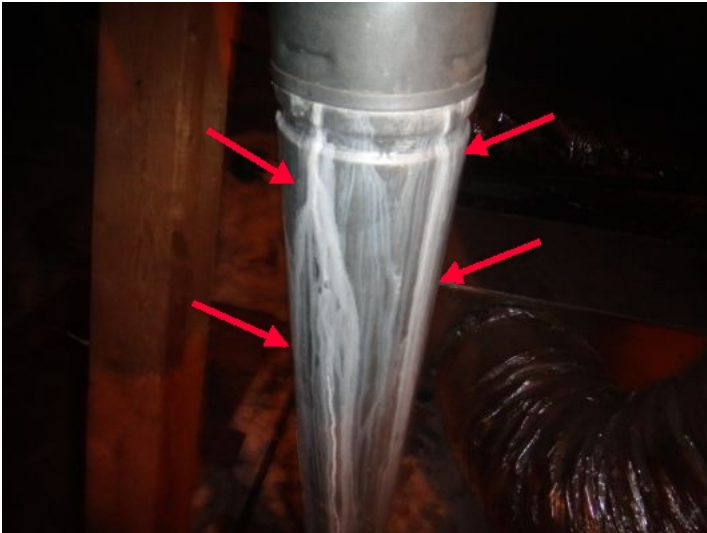
- Water heater vent shows evidence of previous leakage (See photo)

Water heater vent shows evidence of previous leakage (See photo)

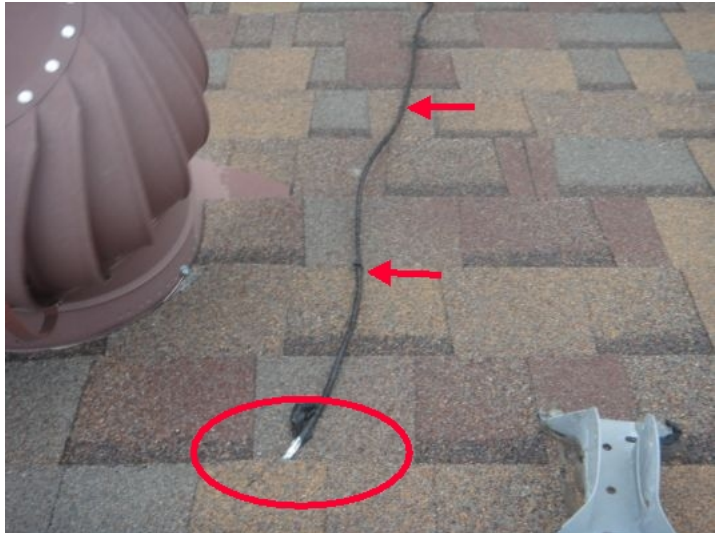
- Abandoned / unused TV coax exits attic through shingle layer at east - not typical - can result in leakage (See photo)

Abandoned / unused TV coax exits attic through shingle layer at east - not typical - can result in leakage (See photo)

- Note: Recommend further evaluation by roofing specialist for repair options / costs

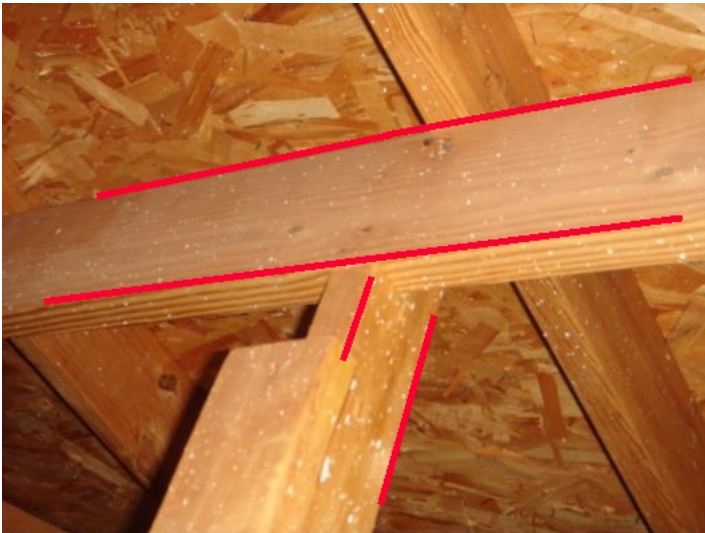
*Note: Roof structure not built per current building codes - 2x6 roof rafters & purlin rails supported by 2x4 purlin struts - typical for age of home - discuss code change (See photo)*

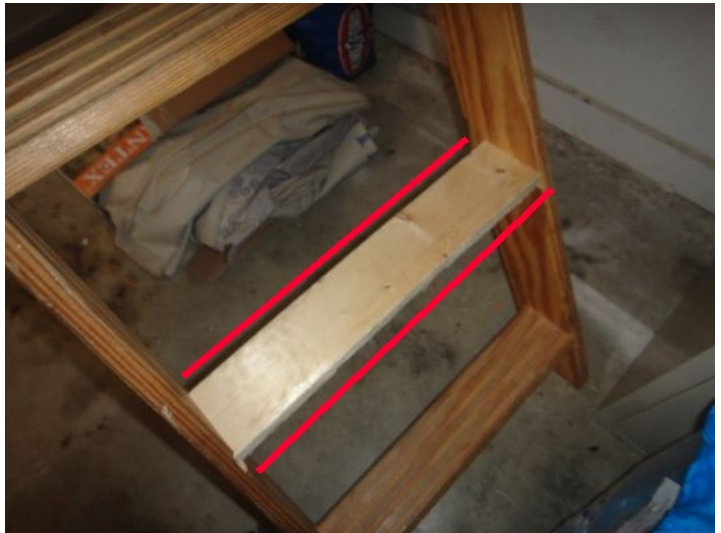
*Garage attic fold down stairway has a repaired & unsupported wood step - potential hazard - discuss (See photo)*

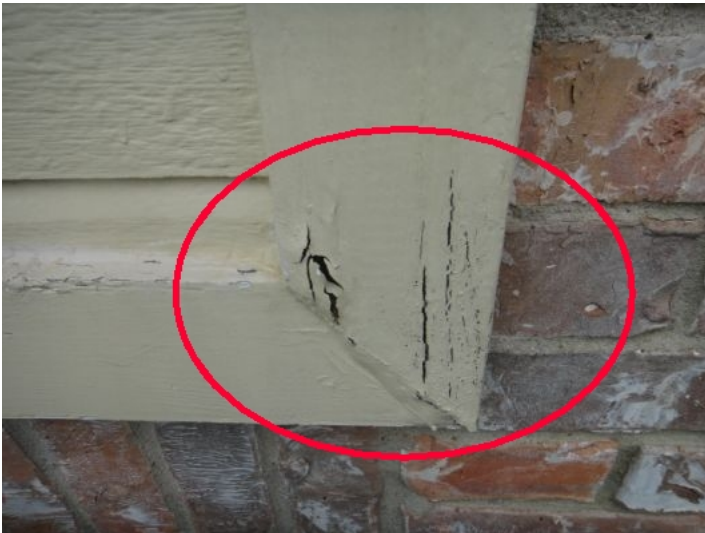
*Water damage to master bath window trim (See photo)*

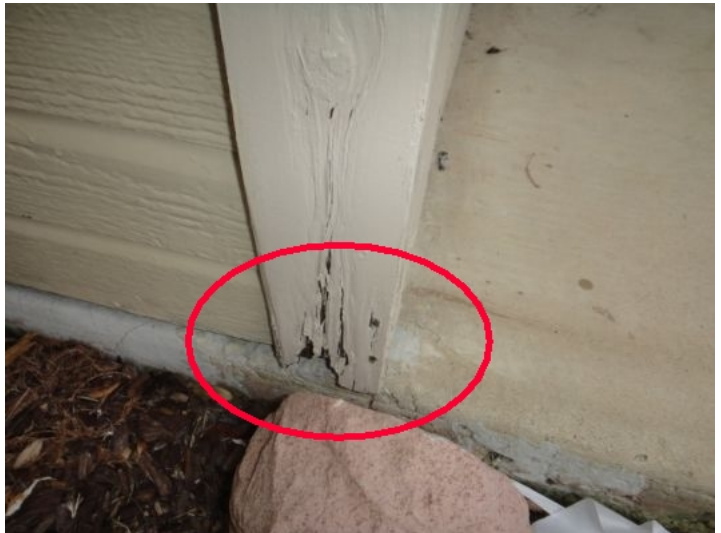
*Water damage to vertical wood trim at end of front patio (See photo)*

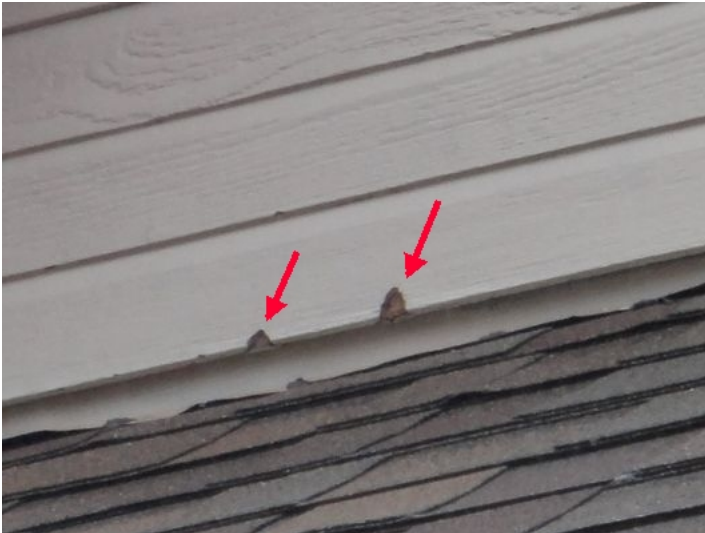
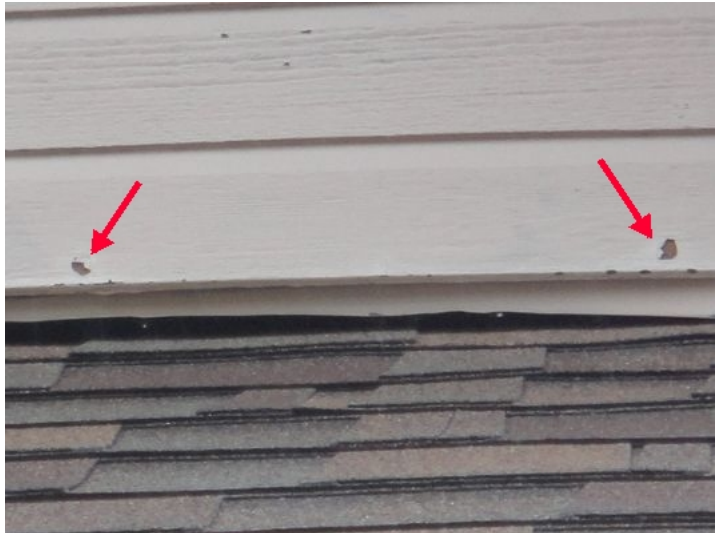
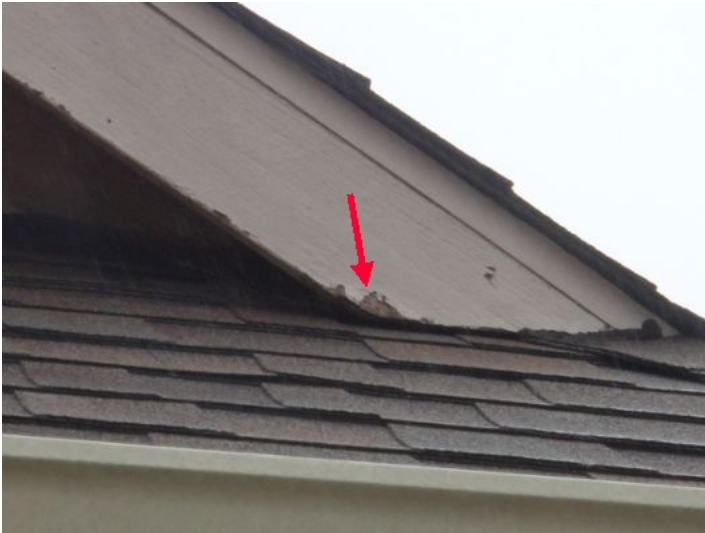
*Damaged area to wood siding at west roof gable above front patio - possibly caused by hail strikes - discuss (See photos)*

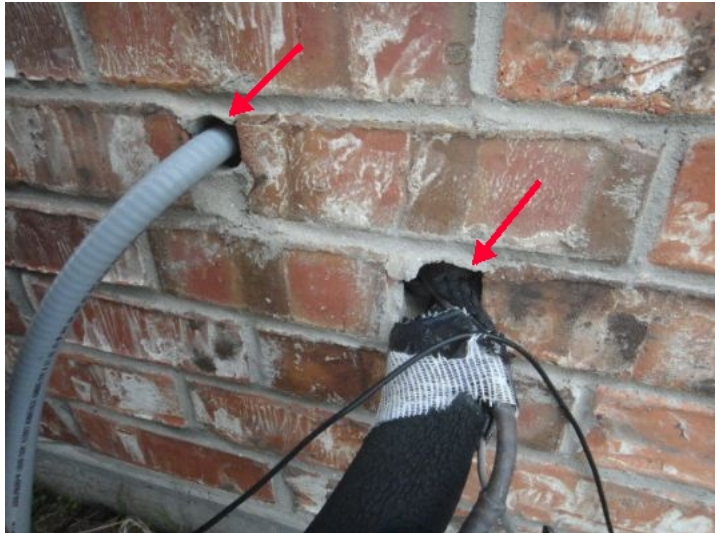
*Air conditioner electrical and refrigerant lines are not sealed at brick penetration (See photo)*

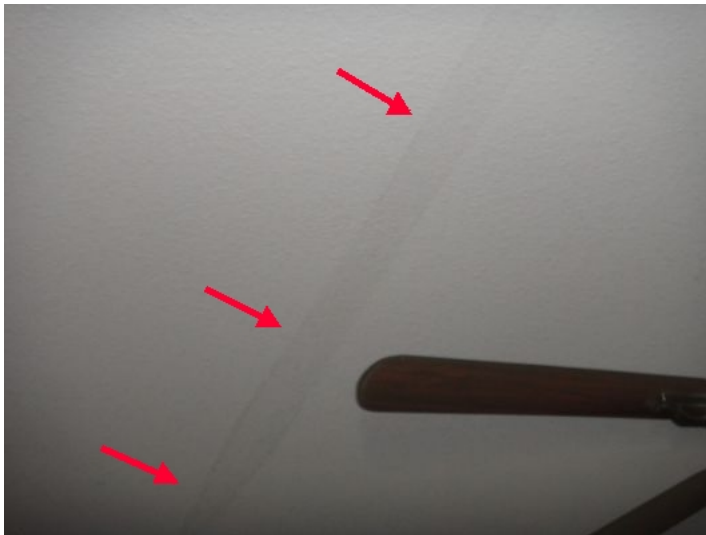
*Note: Minor water stain across study ceiling - no evidence of current leakage noted - consult seller for leak / repair history (See photo)*

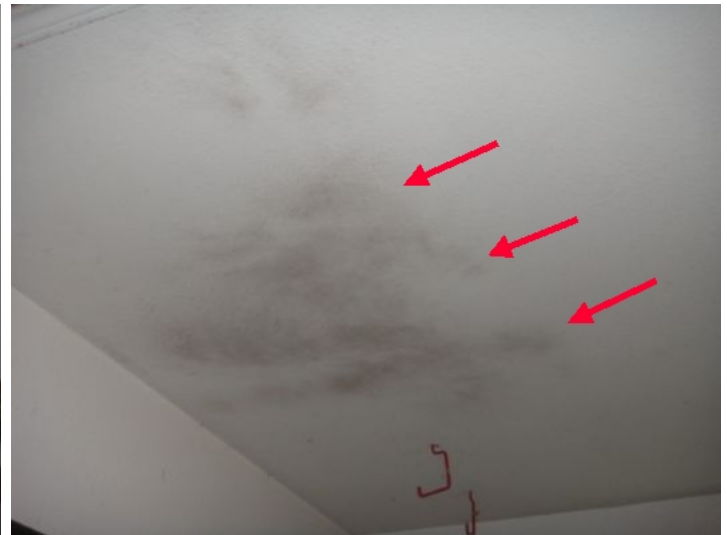
*Note: Discoloration at garage ceiling area - cause not determined - consult seller (See photo)*

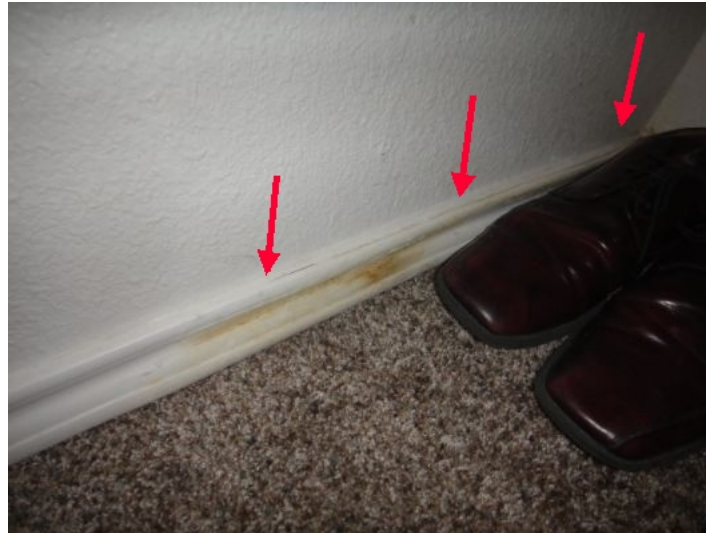
*Note: Obvious water stain to base board in master closet near shower from previous leakage - recommend to consult seller for specific flood / repair history (See photo)*

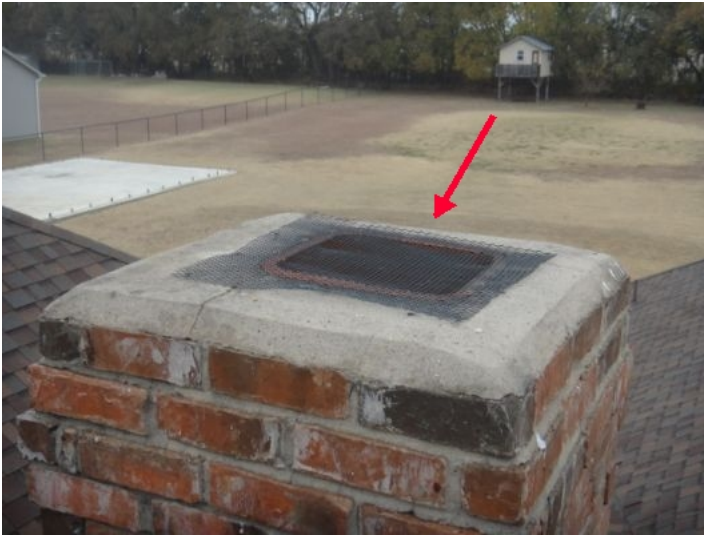
*Chimney top does not have a rain cap or spark arrestor installed - not required at time of construction but recommended ( See photo )*

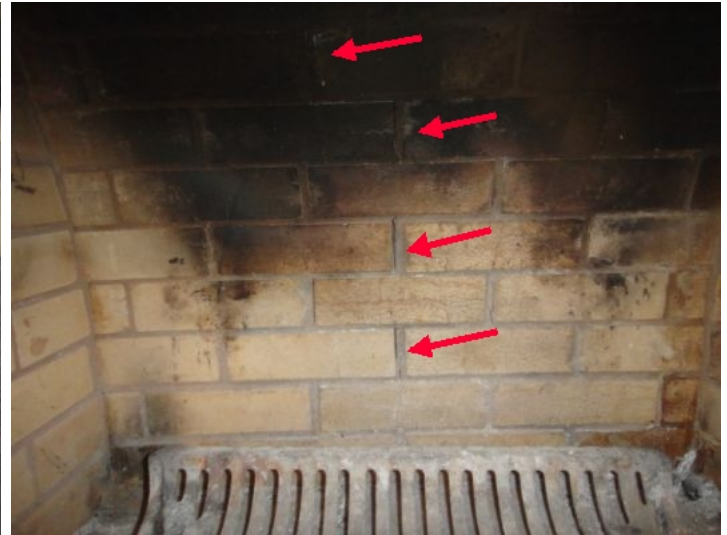
*1/8 inch masonry cracks were present at rear firebox wall and is in need of corrective action (Difficult to see in photo)*

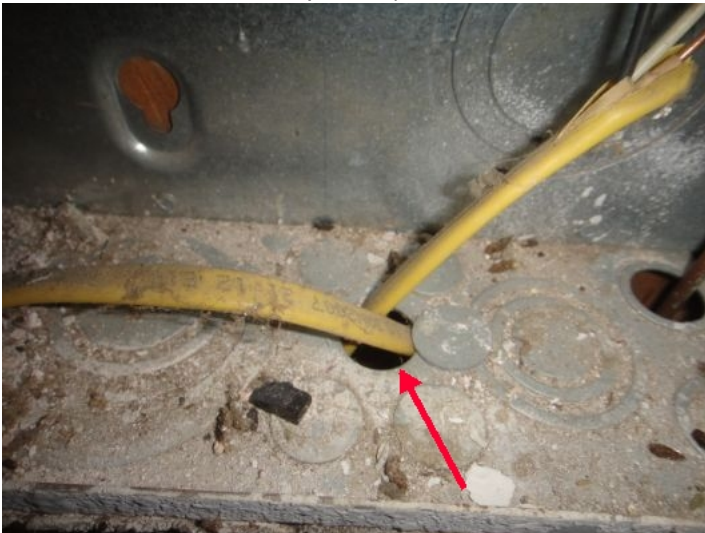
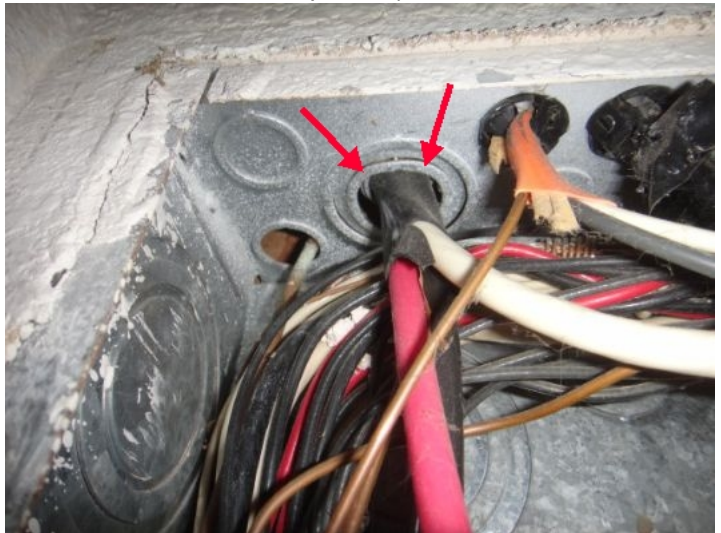
Added wiring exits electric panel with no feed through fittings installed - purpose of feed through fitting is to prevent abrasion to wiring - minor repair ( See photo )

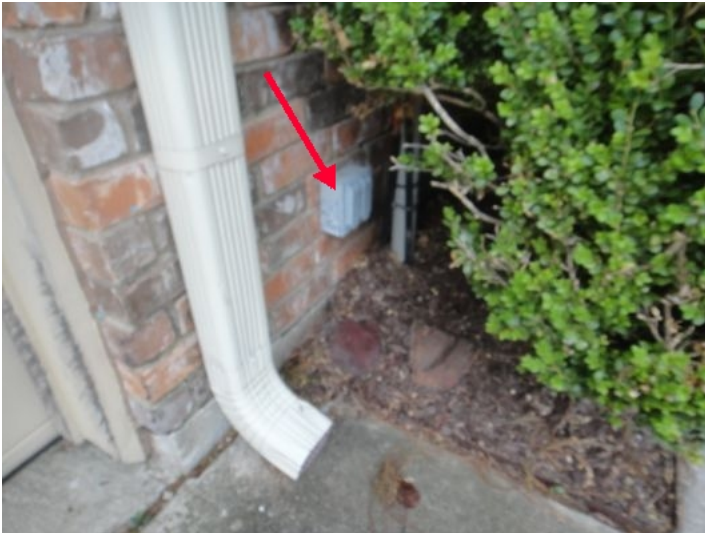
*Added exterior outlets near garage are not GFCI protected as required at time of construction - potential hazard (See photo)*

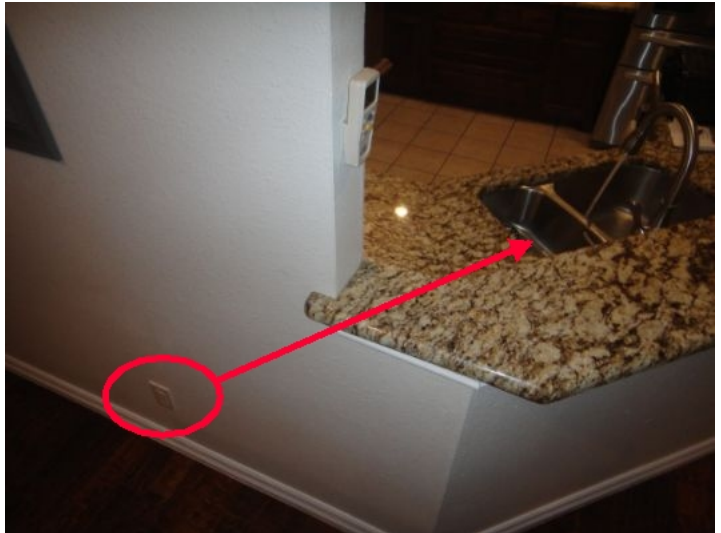
*1 living room wall outlet is within 6 feet of kitchen sink & is not GFCI protected (See photo)*

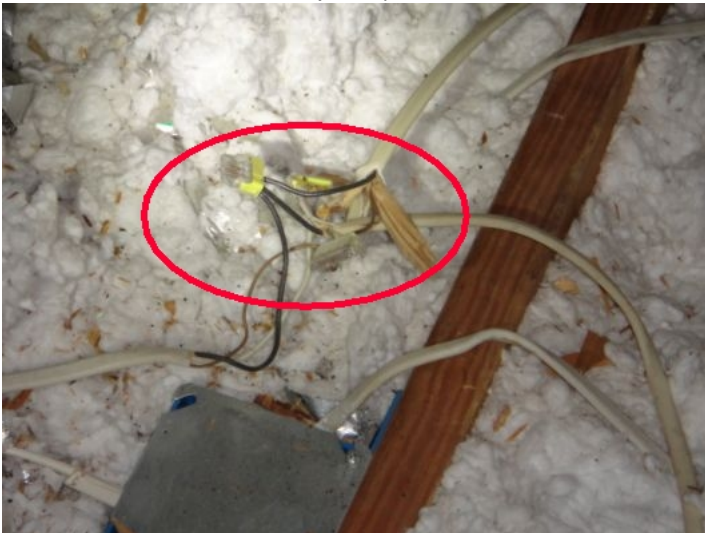
*Exposed 110 volt electrical connections not in junction box in attic as required - potential hazard (See photo)*

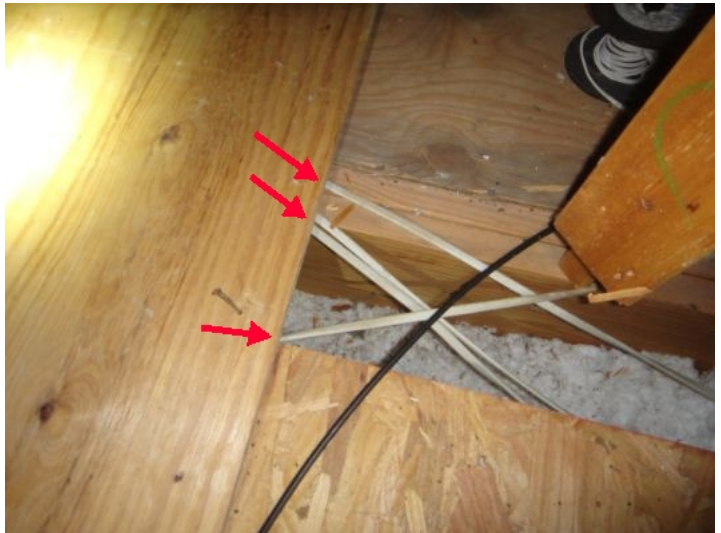
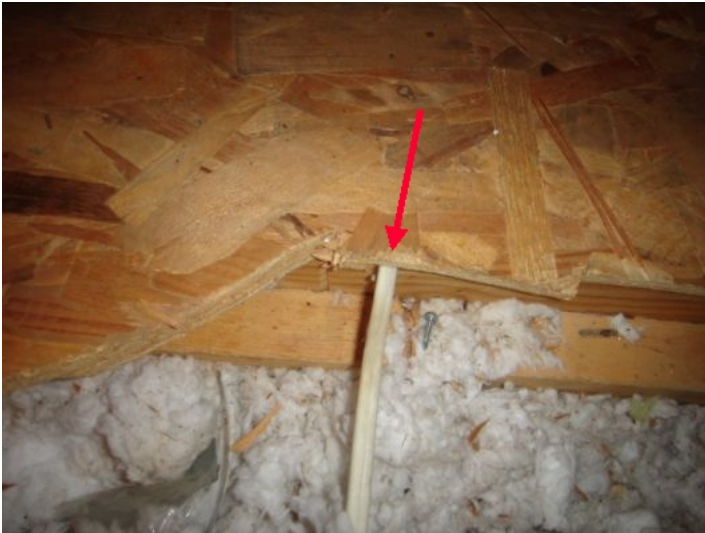
*110 volt wiring pinched by added wood flooring decking in north attic - not typical - potential hazard - needs repair - discuss with client (See photos)*

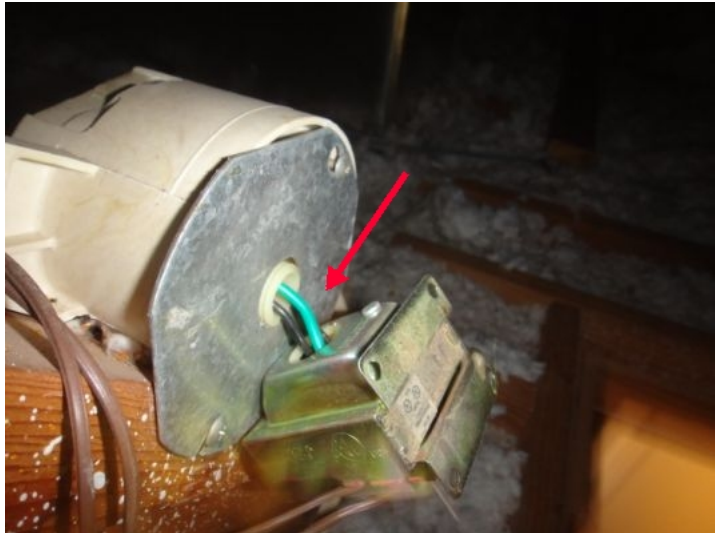
Door bell transformer ( SW attic area ) is loose and hanging by wiring from junction box - not typical (See photo)

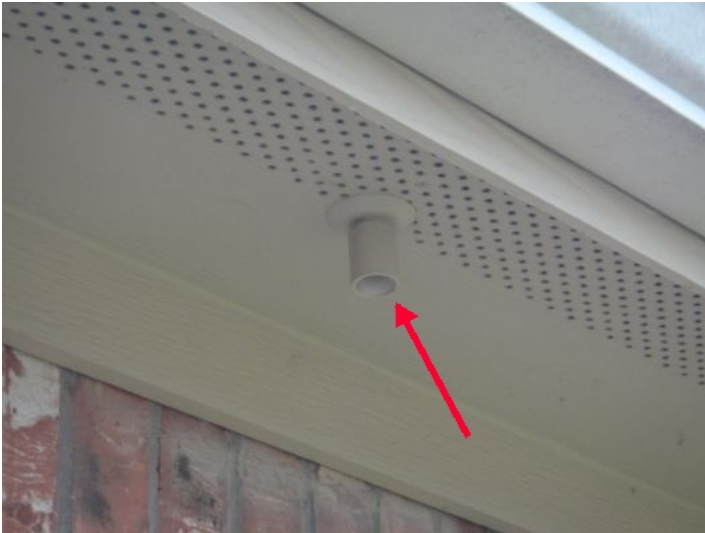
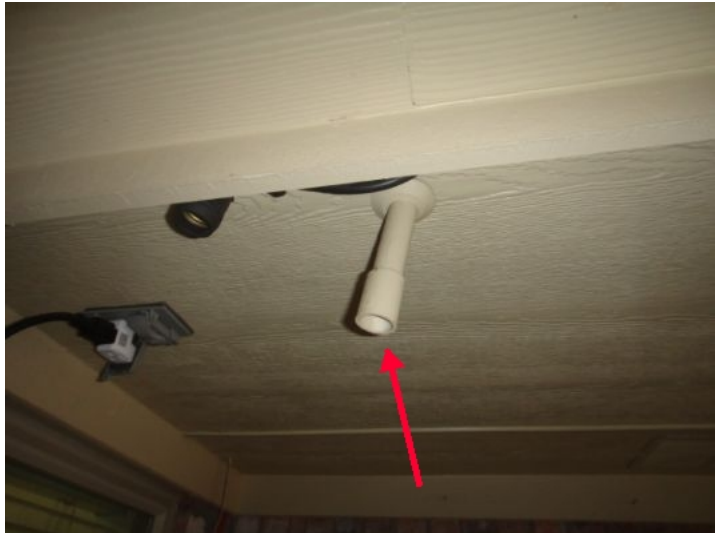
*Note: Secondary condensate drain line exits attic at roof overhang - leakage from this drain would indicate a problem with air conditioner system requiring immediate service (See photo)*

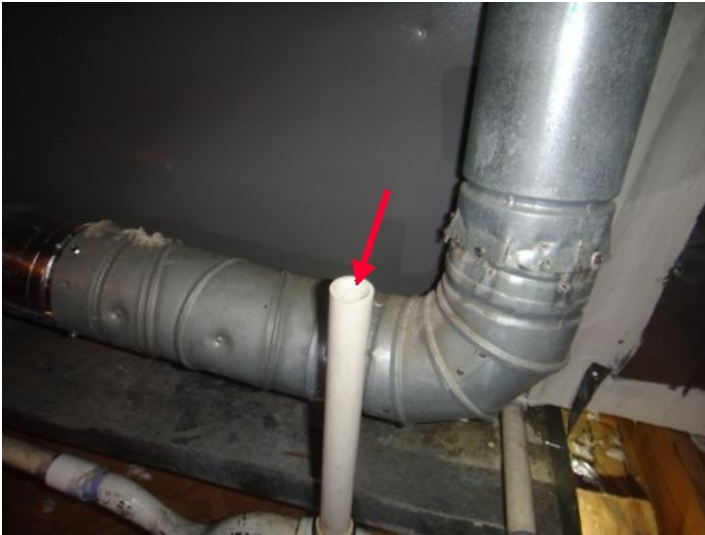
*Note: Discuss addition of bleach into primary condensate drain lines near evaporator coils in attic - helps prevent clogging (See photo)*

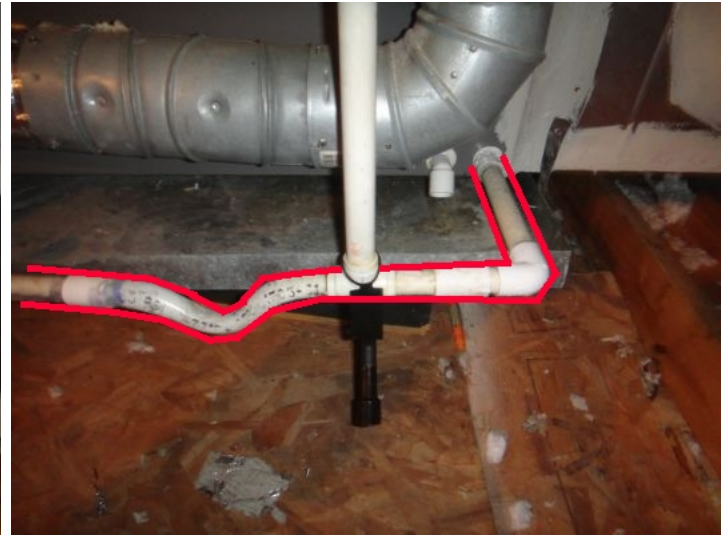
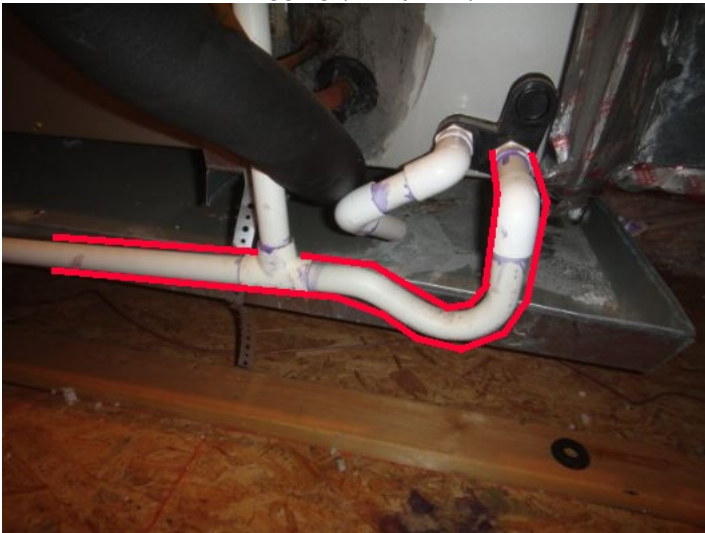
*Both primary condensate drain lines are not insulated where exits evaporator coil - will drip condensate - minor repair (See photo)*

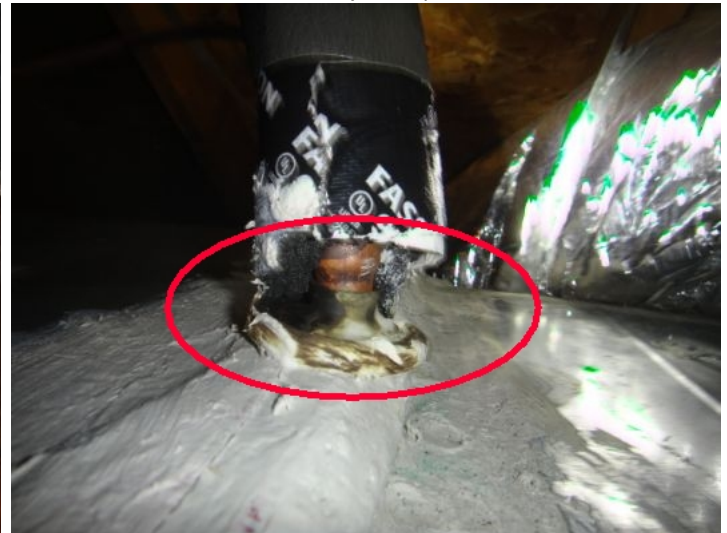
*Incomplete refrigerant line insulation at evaporator coil in north attic at garage - will drip condensate - minor repair (See photo)*

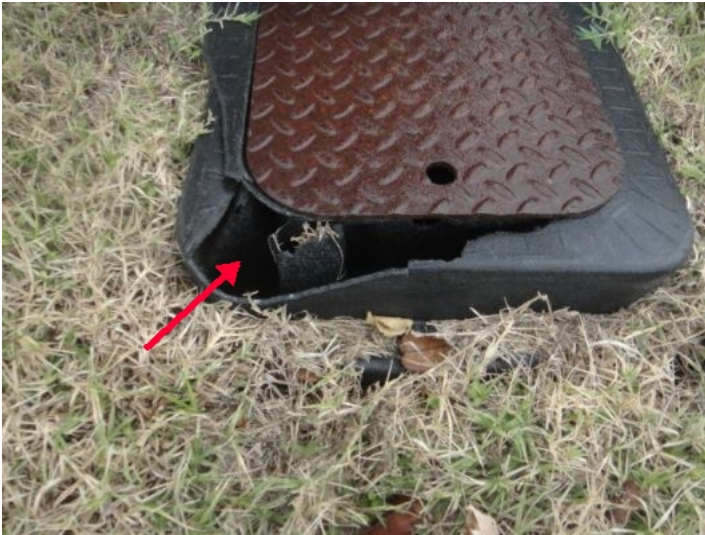
Note: Plastic water meter box in front yard shows physical damage - but functional (See photo)

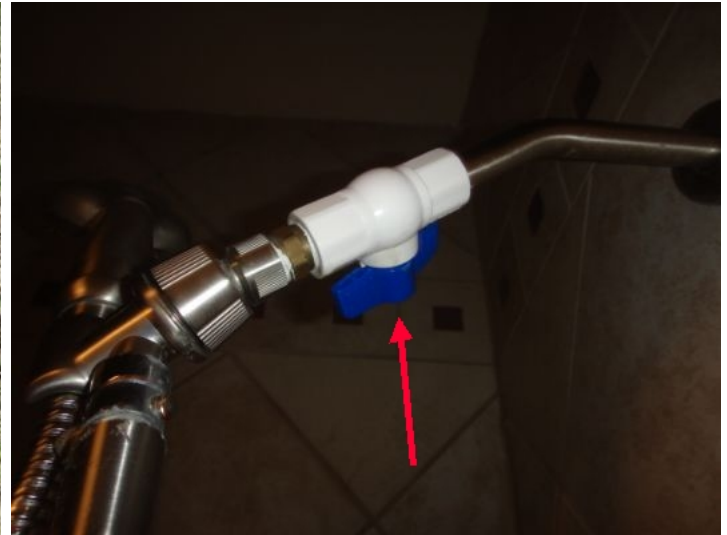
Note: Master shower neck has an added plastic shut off valve - purpose not determined - consult seller (See photo)

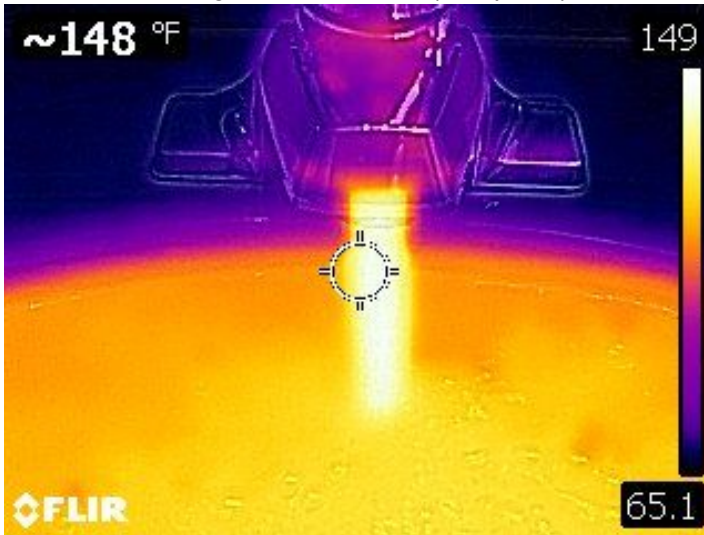
Garage water heater has output temperature too high at 148 degrees F. measured at master bath sink faucet - extreme hazard (See photo & scald chart)

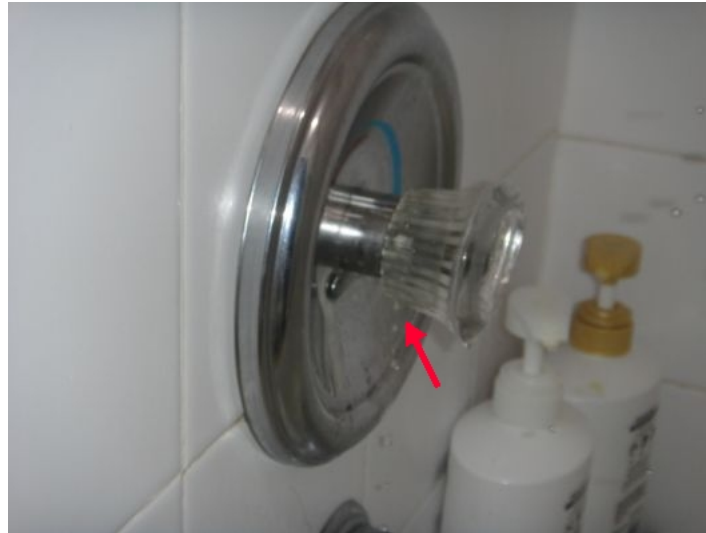
SW hall bath shower mix valve leaks at control stem from behind plastic knob when on - not typical (See photo)

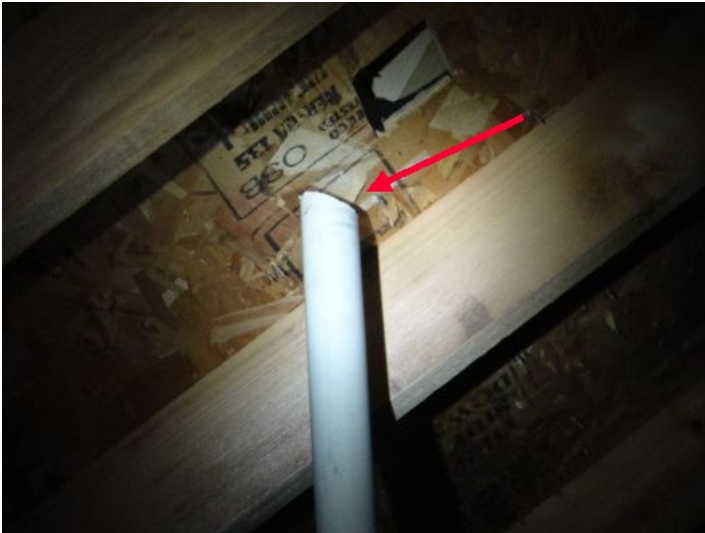
Observed 1 plumbing vent stack in north attic area does not penetrate roof as intended - this can result in sewer gas entering attic space (See photo)

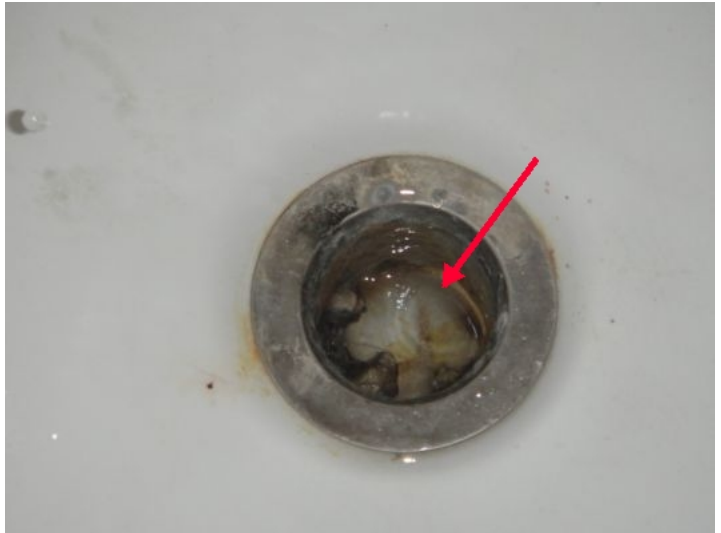
SW hall bath tub drain fitting shows obvious corrosion with missing sections - cannot connect drain stop as intended (See photo)

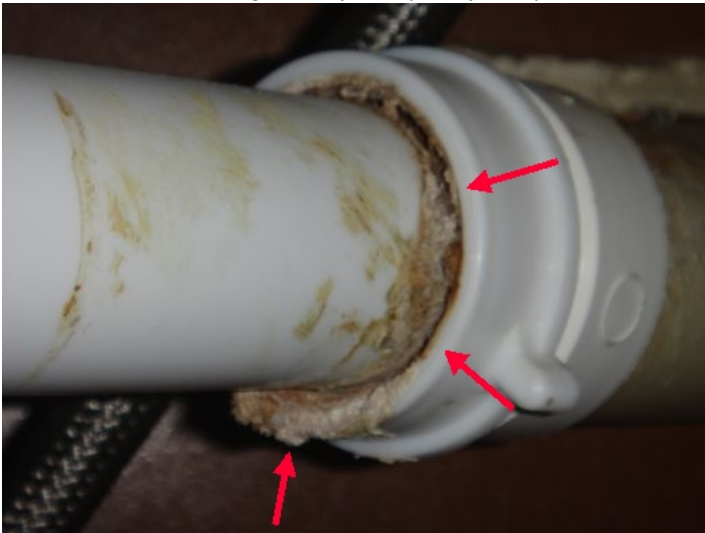
SW hall bath sink drain connection shows evidence of previous leakage - no current leakage noted - recommend to monitor (See photo)
