## PROPERTY INSPECTION REPORT

**123 North Texas Dr., Your town, Texas 75001**

**Date of Inspection: 11/11/2019 Time: 10:30am - Report#: 19115234**

**Inspector: Glen P. Ford**

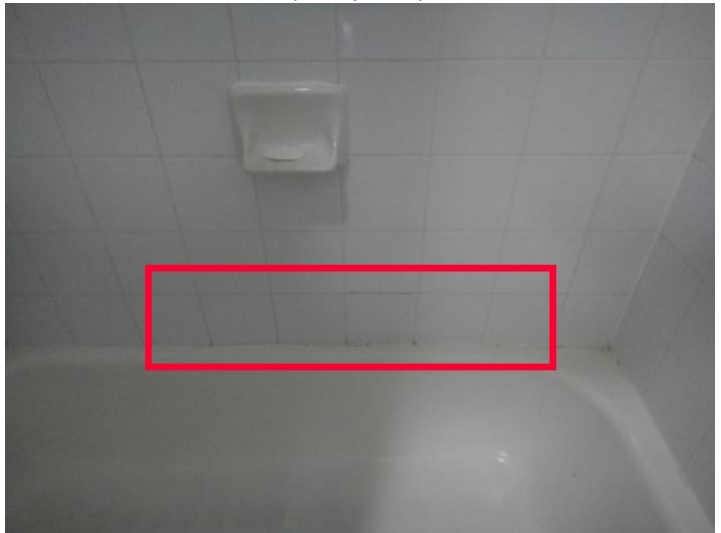
SW hall bath shower tile wall needs caulking repair at random areas & has some tiles starting to unbonded at lower rear wall area (See photo) - discuss age with client

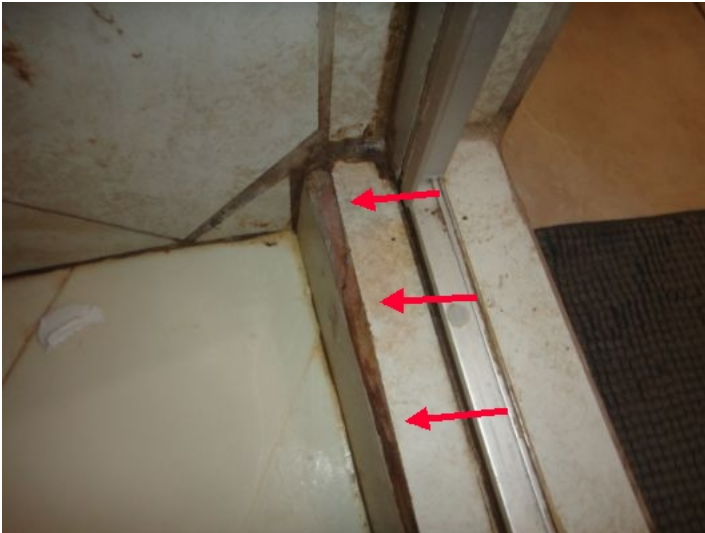
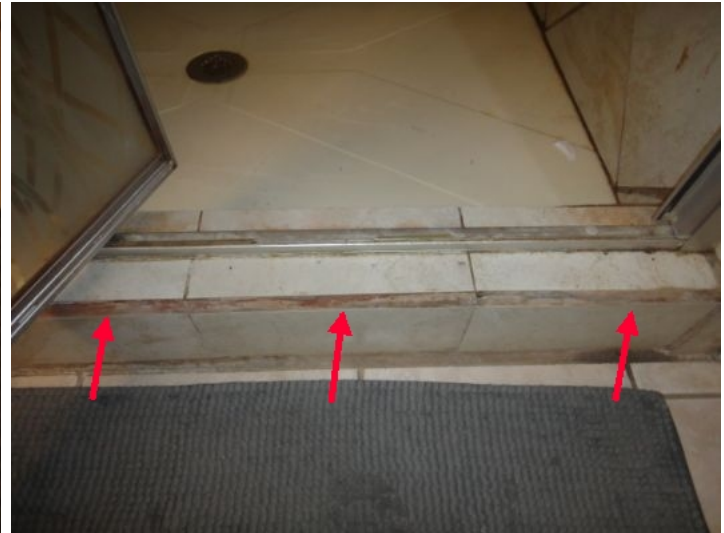
Master bath shower tile wall has failed grout / caulk at random, loose unbonded tiles at door threshold areas typical of age - discuss & show to client (See photos)

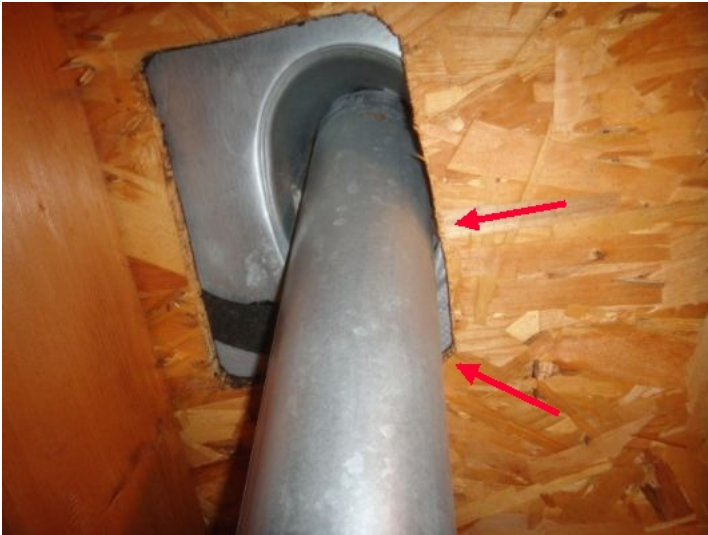
Water heater gas vent pipe in contact with wood roof decking in attic - Fire Hazard - Type "B" gas vent pipes require 1 inch clearance to combustibles - General Repair (See photo)

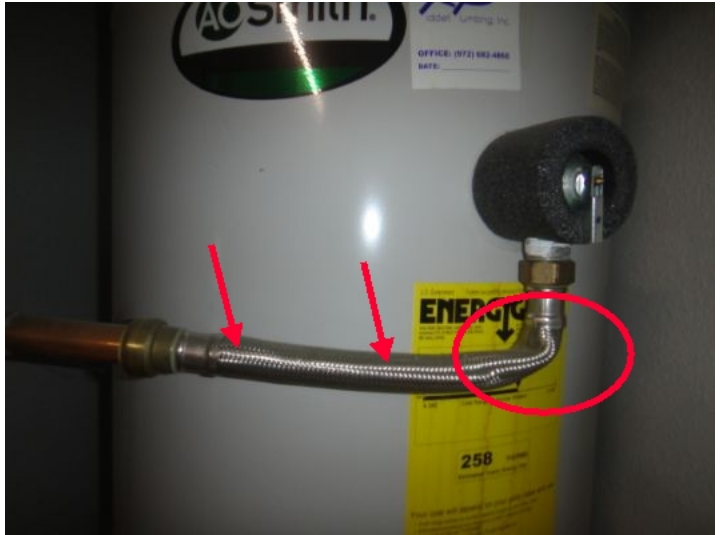
Garage water heater TPR valve connected with non approved flexible hose & is kinked restricting inside diameter - needs repair - Copper or CPVC pipe recommended (See photo)

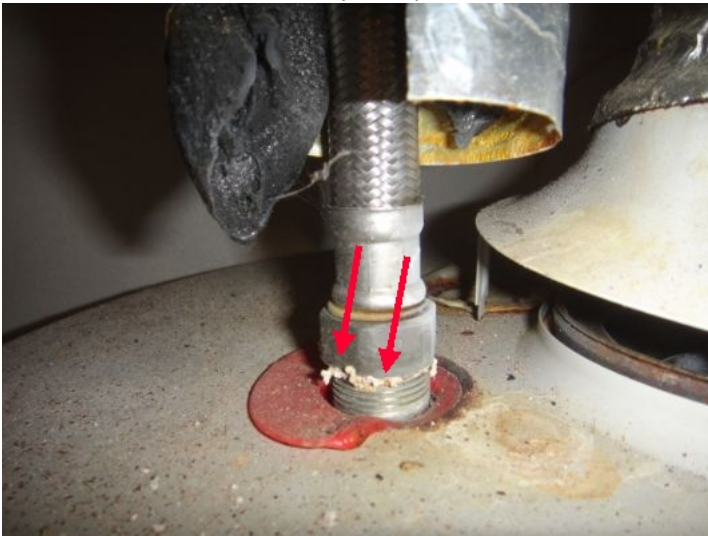
Garage water heater shows evidence of seepage at hot water line connection point (See photo)

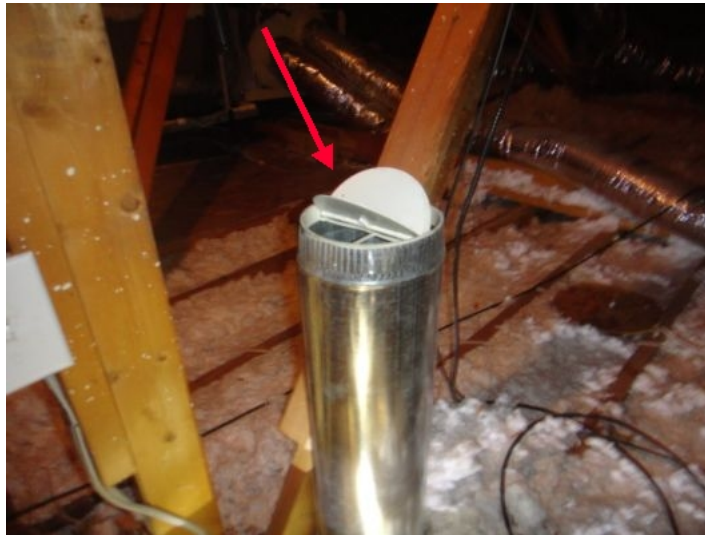
*Range vent was terminated in the attic - not typical - should vent to exterior (See photo)*

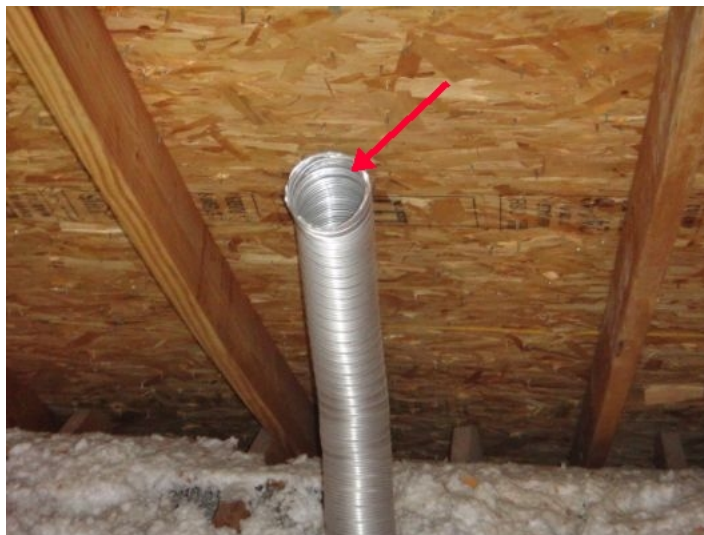
Bathroom exhaust fans vent directly into attic space as allowed at time of construction - current code requires vents to terminate at exterior of structure.
