TEXAS OFFICIAL WOOD DESTROYING INSECT REPORT

1A. A-TEX INSPECTION, INC. 1B. TPCL 11269
Name of Inspection Company SPCS Business License Number
1C. 2875 Briar Trail Mckinney, Texas 75069 (972) 625-2129
Address of Inspection Company City/State Zip Telephone number
1D. GLEN P. FORD 1E. Certified Applicator (Check one)
Name of Inspector (Please Print) Technician

5. RESIDENCE

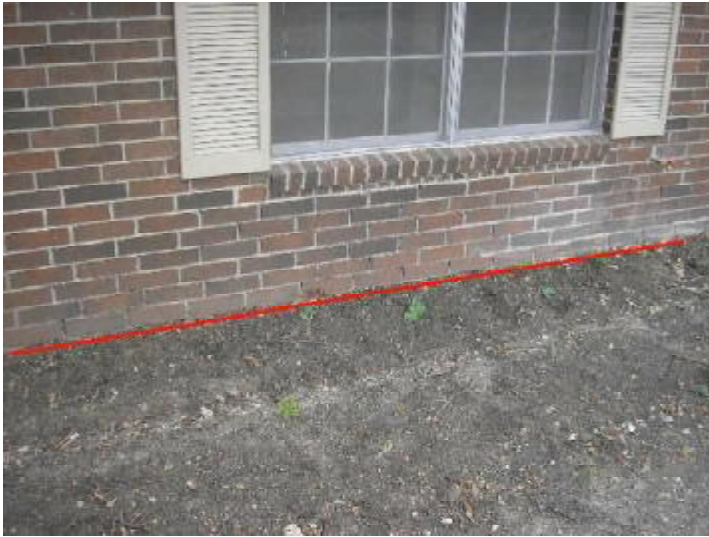
PHOTO 1

SOIL LINE TOO HIGH AT RANDOM FOUNDATION PERIMETER AREAS-
CONDUCTIVE CONDITION

9B. Preventive treatment and/or correction of conducive conditions as identified in 7A & 7B is recommended as follows: Yes No
 Specify reason: RECOMMEND TO RESOLVE CONDUCTIVE CONDITIONS TO MINIMIZE CHANCE OF FUTURE INFESTATION;

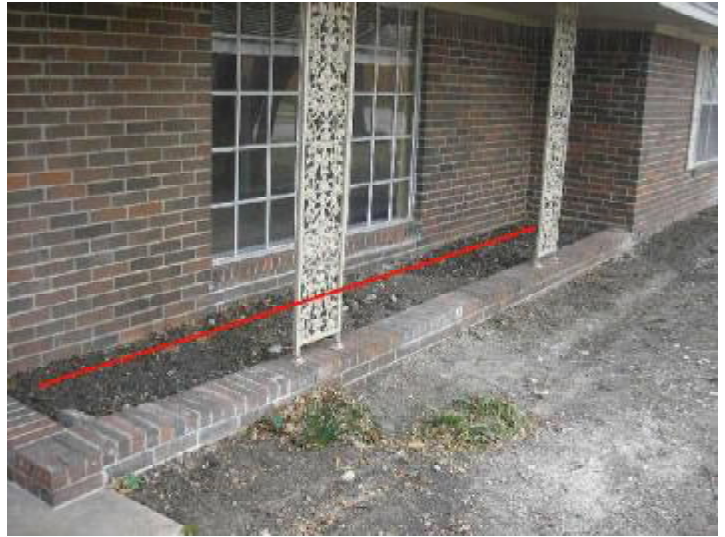
PHOTO 2

BRICK PLANTER BOX HOLDS SOIL ABOVE BRICK LINE BY BUILDERS
DESIGN - CONDUCTIVE CONDITION
