## PROPERTY INSPECTION REPORT

**123 Your Street, Your Town, Texas 75001**

**Date of Inspection: 12/10/2019 Time: 10:30am - Report#: 19121342**

**Inspector: Glen P. Ford**

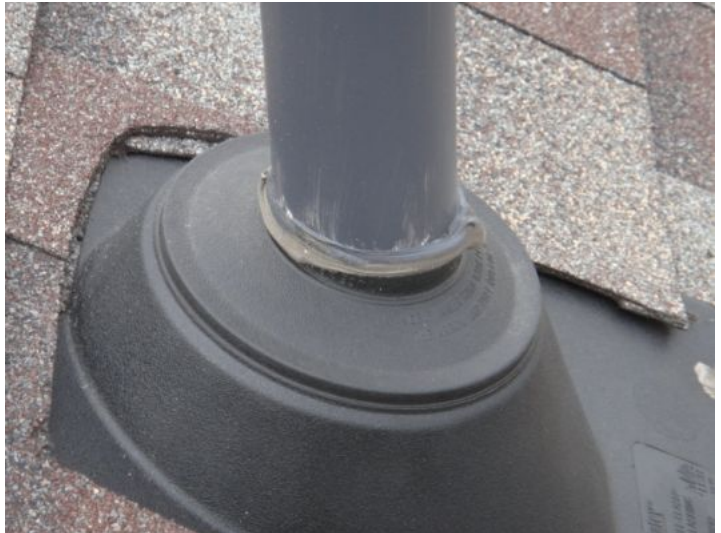
1 north plumbing vent roof jack has rubber seal inverted - will hold water - not typical - minor repair (See next photo)

View of properly installed roof jack seal

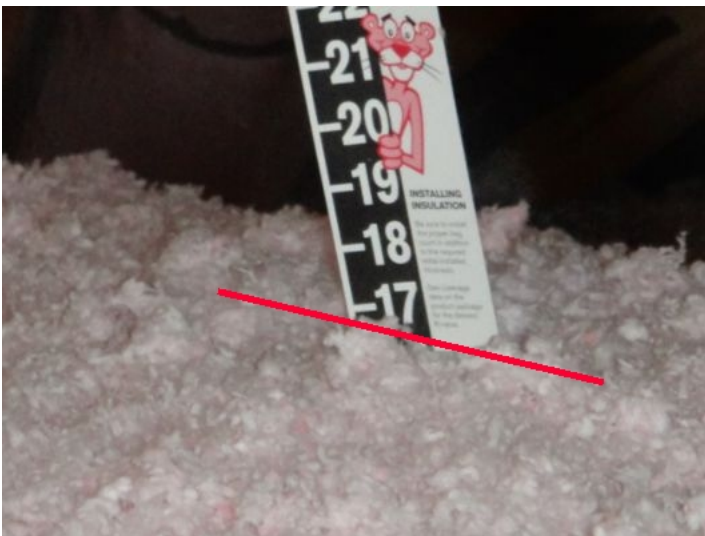
- Blown ceiling insulation is loose / disturbed at areas above den caused by worker foot traffic - no longer at posted depth in this area - discuss with client (See photo)

*Note: View of insulation installers depth marker*

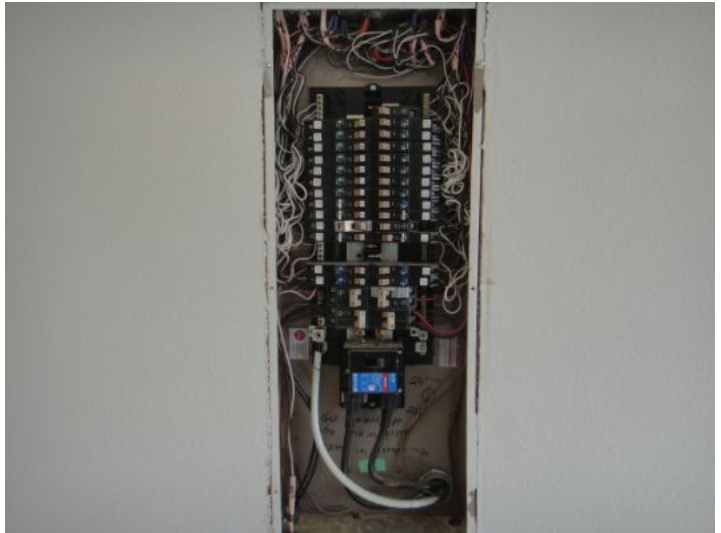
Electric panel cover removed for inspection - no defects found ( See photo )

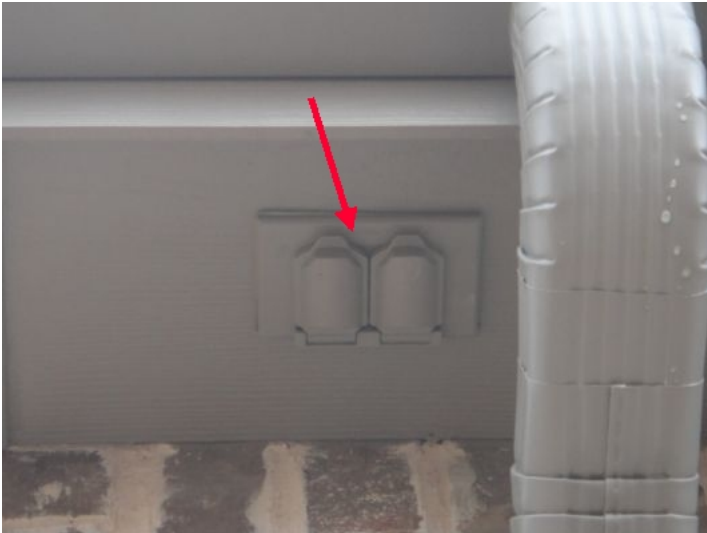
Note: Discuss soffit outlets installed for x-mas lights - power controlled by switch - consult builder for specifics (See photo)

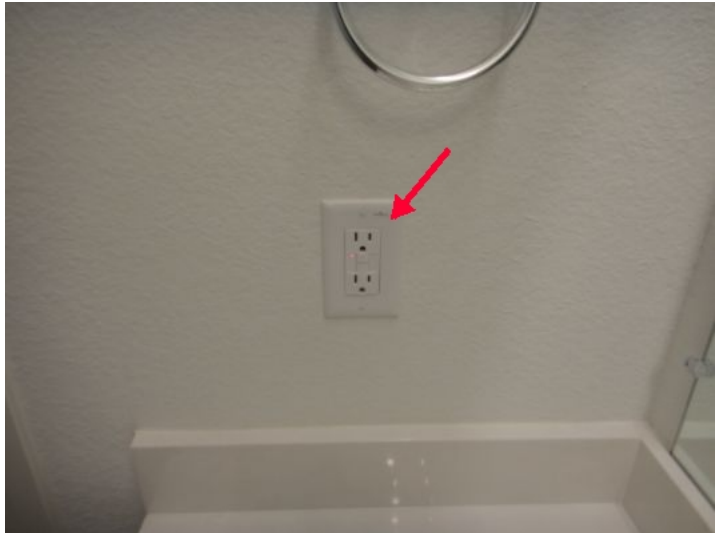
Note: GFCI device in hall bath room protects all bathroom outlets in home - discuss

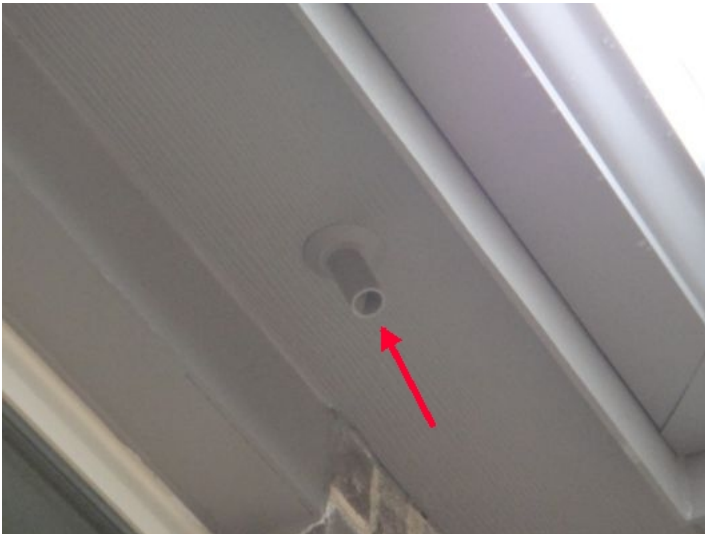
*Note: Secondary condensate drain line exits attic at east near rear patio - leakage from this drain would indicate a problem with air conditioner system requiring immediate service (See photo)*

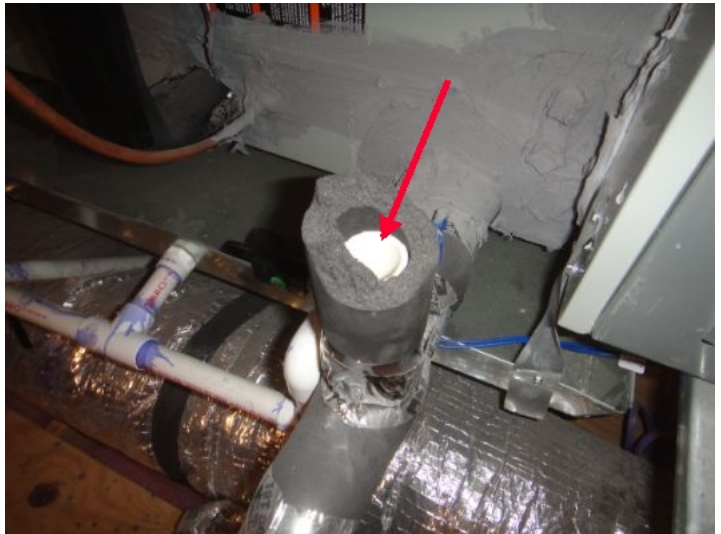
*Note: Discuss addition of bleach into primary condensate drain line near evaporator coil in attic - helps prevent clogging (See photo)*

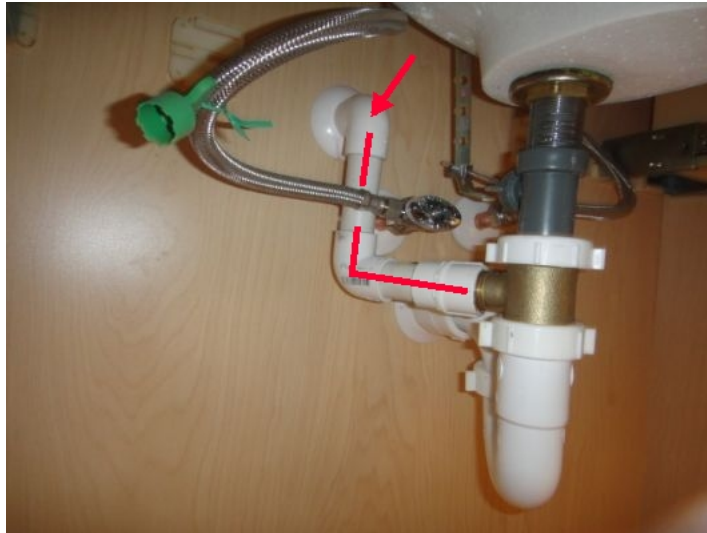
*Note: Primary condensate drain line ( from evaporator coil in attic ) terminates into plumbing below hall bath LH sink (See photo)*

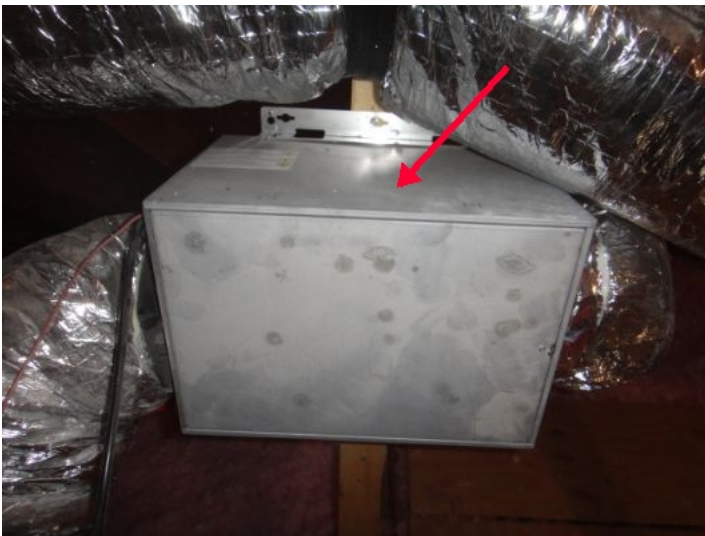
*Note: Discuss fresh air ventilation controller installed in attic - this device allows fresh outdoor air to be introduced into living space to improve overall air quality inside home - consult builder for specifics (See next photo)*

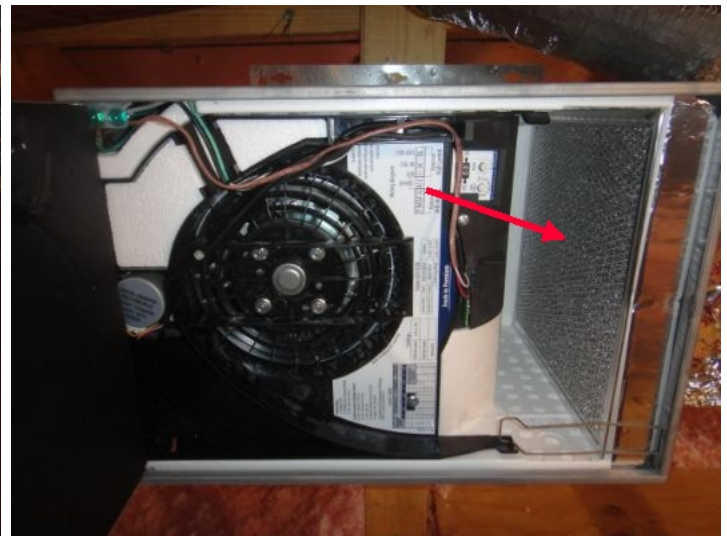
*- This device has its own internal air filter that requires periodic service*

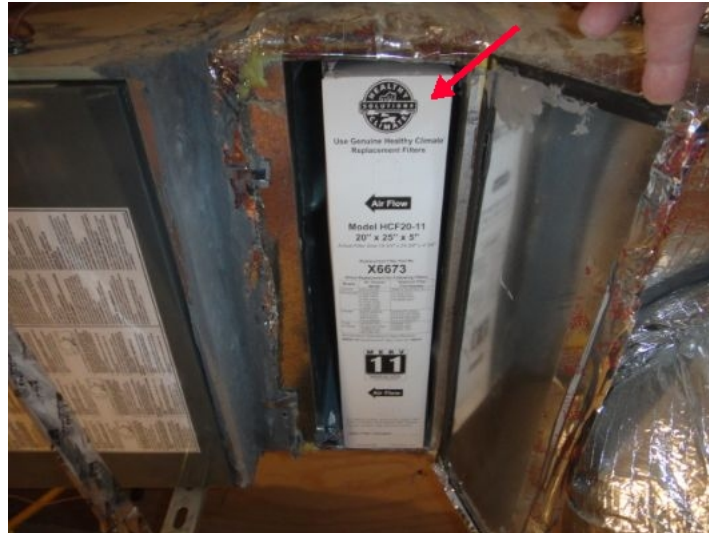
Note: Air filter changed at air handler unit in attic (See photo)

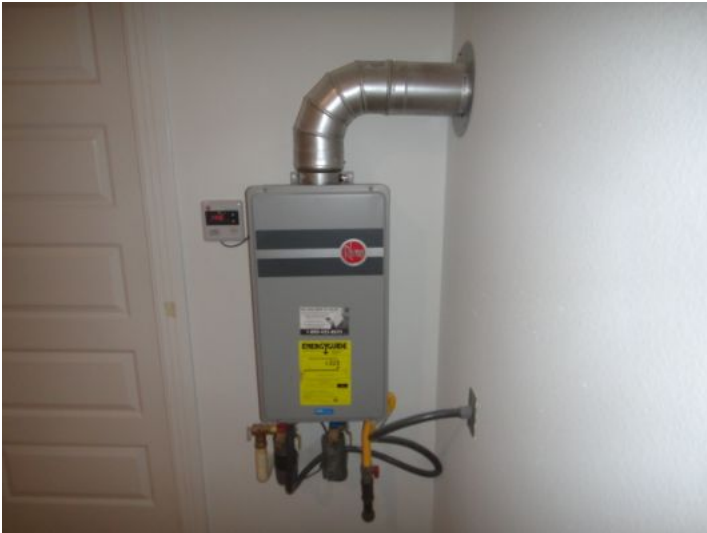
*Note: Tankless water heater functioning as intended - no defects found*

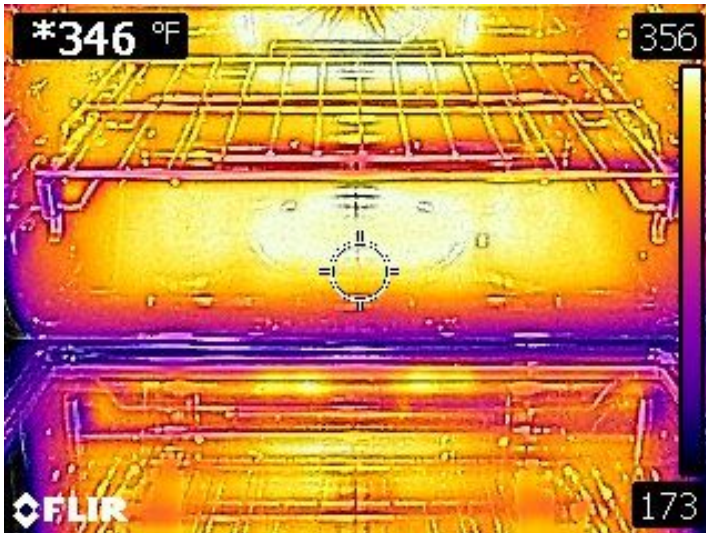
Upper oven - thermal camera shows accuracy on 350 degree setting

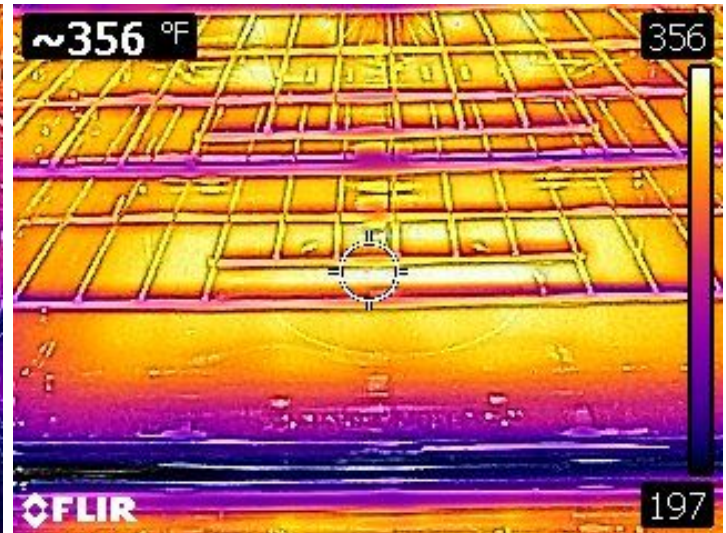
Lower oven - thermal camera shows accuracy on 350 degree setting
