## PROPERTY INSPECTION REPORT

**123 North Texas Dr., Your town, Texas 75001**

**Date of Inspection: 11/11/2019 Time: 10:30am - Report#: 19115234**

**Inspector: Glen P. Ford**

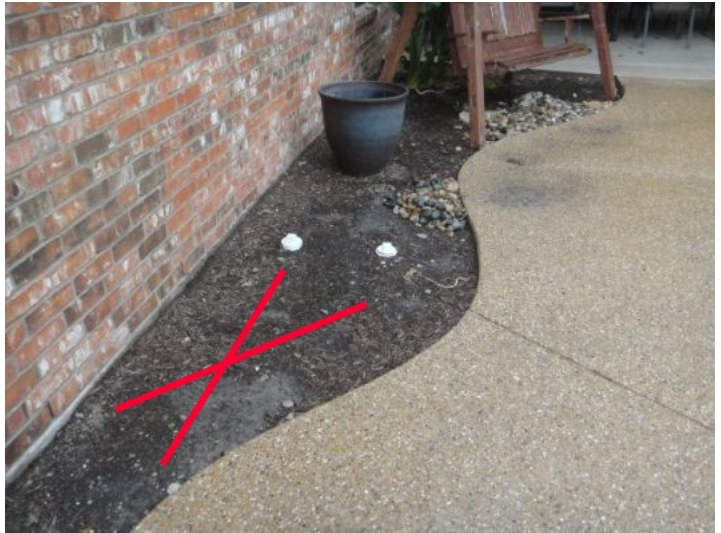
Low area with evidence of water ponding in front flower bed (See photo)

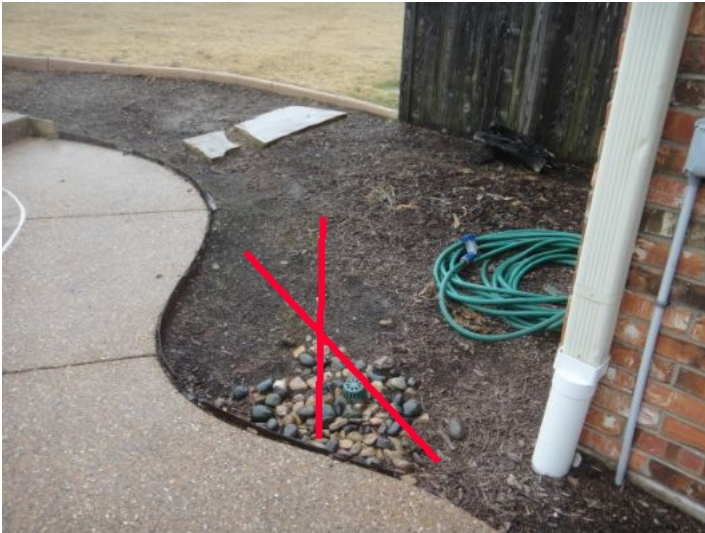
Low areas with evidence of water ponding at rear flower bed areas (See photos)

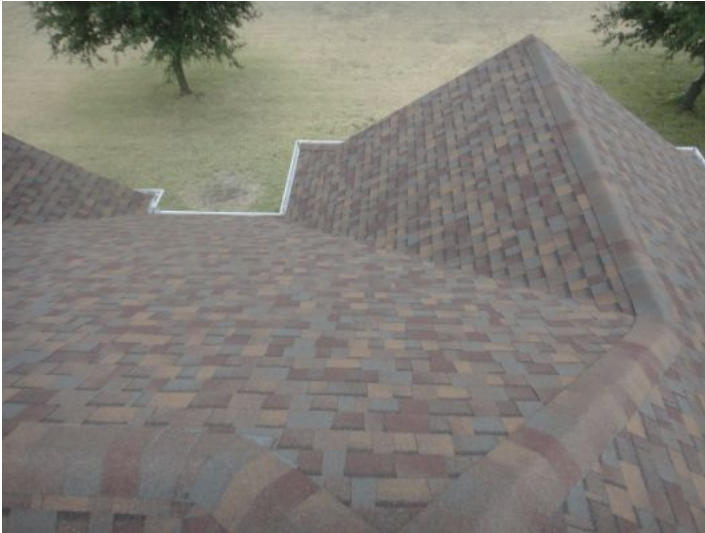
Roof view west

- Abandoned / unused TV coax exits attic through shingle layer at east - not typical - can result in leakage (See photo)

- Note: Recommend further evaluation by roofing specialist for repair options / costs

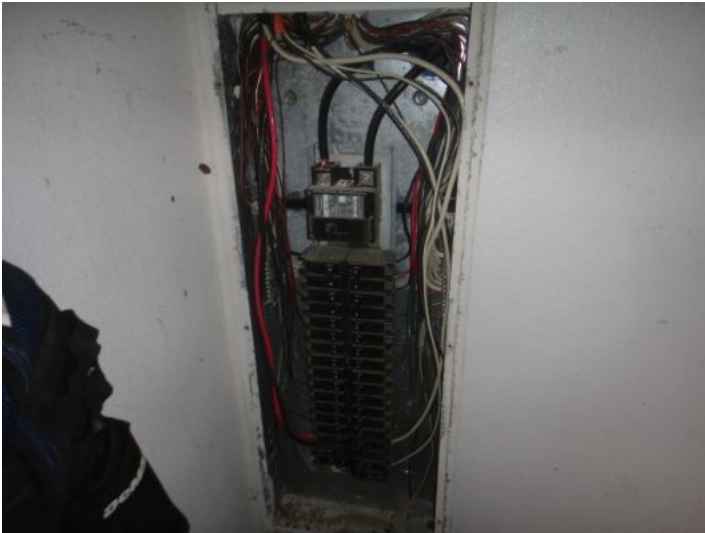
Electric panels located at garage wall & Sub. panel at add-on room wall - panel covers removed for inspection ( See photos )

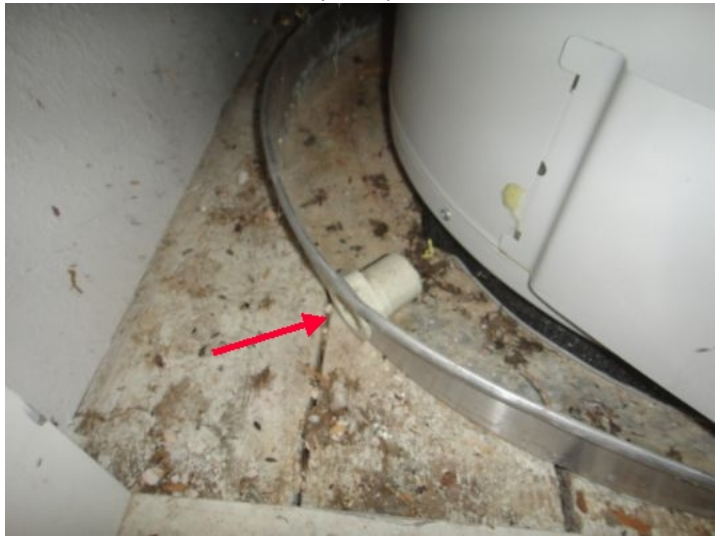
Garage water heater overflow pan does not have drain line to exterior ( See photo ) - discuss code change

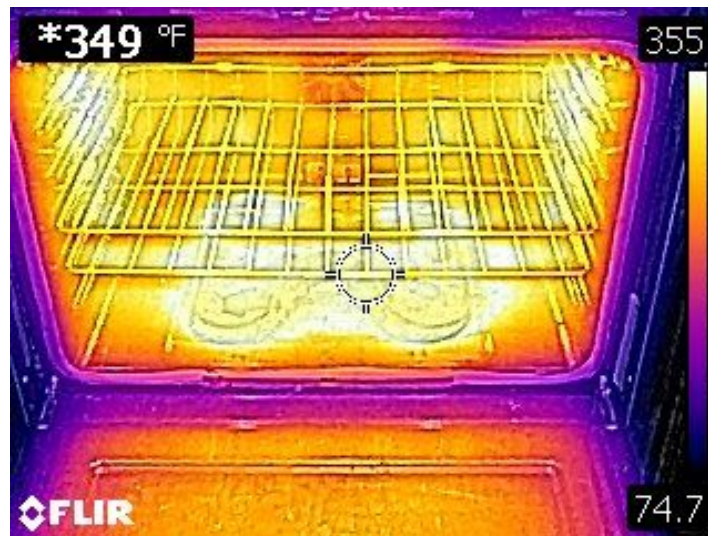
Thermal camera shows oven accuracy on 350 degree setting
